ELECTRICAL SAFETY AUDIT
JUNE 2023

FOR
NIRMALA MEMORIAL
FOUNDATION,
KANDIVALI

Prepared by
M/s. ETCOM ENGINEERING
SERVICES

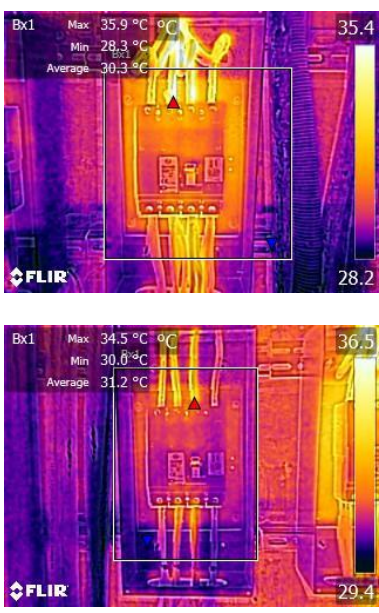
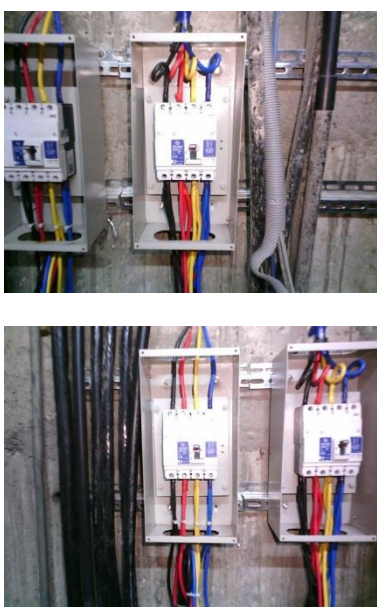
<p>Observation: Maximum temperature observed on MCCB terminals are Bx1: 35.9 °C</p> <p>Bx1: 34.5 °C</p> <p>Recommendation: Found OK.</p>
<p>47</p>	<p>LDB</p>

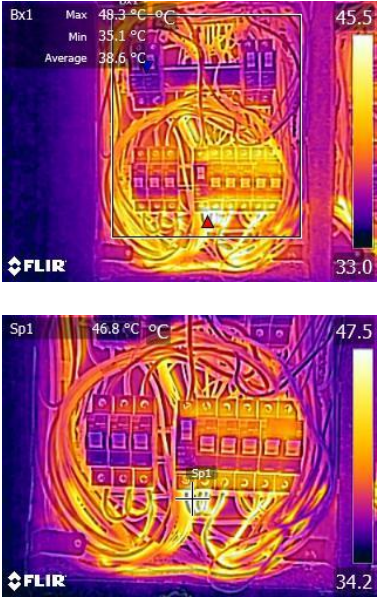
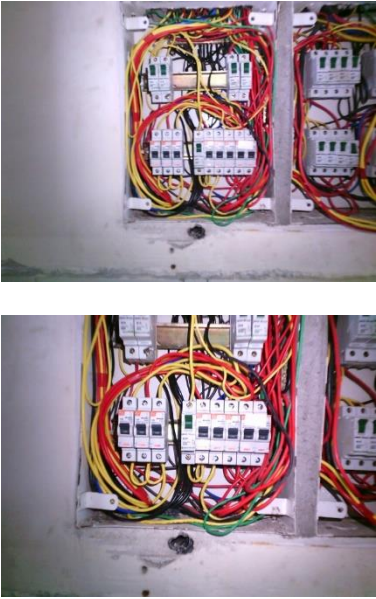
50	ACDB

<p>Observation: Maximum temperature observed on MCB incoming wire terminal is Bx1: 48.3 °C</p> <p>Observation: Maximum temperature observed on MCB incoming wire terminal is Sp1: 46.8 °C</p> <p>Recommendation: It is recommended to removed looping of wire and provide Cu. Shorting link.</p>
51	Main MCCB of 7 th floor

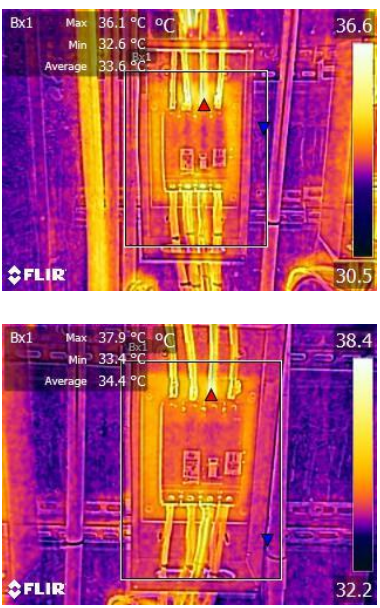
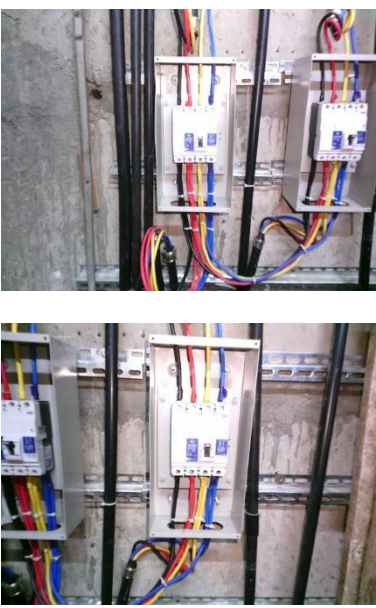
<p>Observation: Maximum temperature observed on MCCB terminals are Bx1: 36.1 °C</p> <p>Bx1: 37.9 °C</p> <p>Recommendation: Found OK.</p>
52	LDB

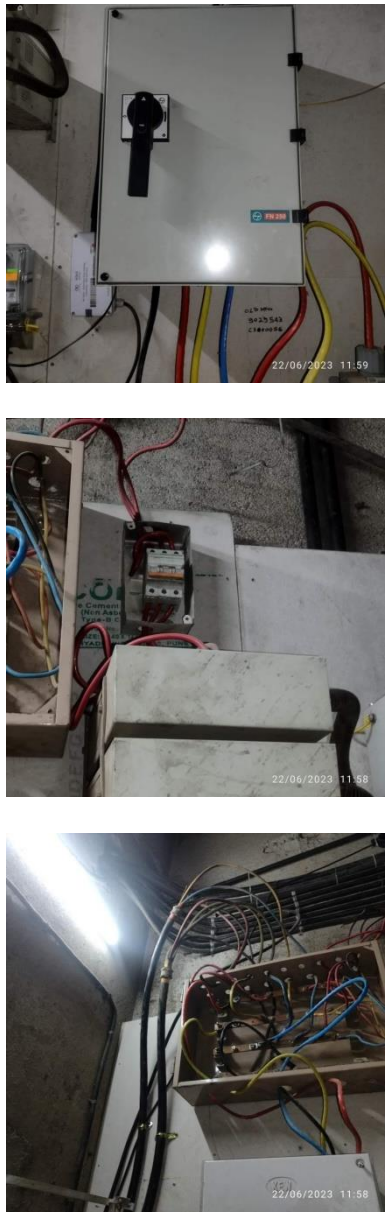
Sr. No.	Location	Image	Description of Defects	Recommendation
1	Adani electricity meter room

<p>1. Insulation Rubber mat is not available in front of electrical installations.</p> <p>2. Display of Instructions chart for resuscitation of persons suffering from electric shock is not affix in electrical meter room.</p> <p>3. Danger Notice is not affixed on electrical panel and DB.</p> <p>4. Electrical Single line diagram of electrical installation is not available near electrical panel/DB.</p> <p>5. Proper Tagging on all SFU switch/Cable is not provided for identification.</p>	<p>1. It is recommended to place Insulation Rubber mat having IS 15652:2006 standard in front of electrical panel as per CEA Regulation19 (5).</p> <p>2. It is recommended to affix display of Instructions for resuscitation of persons suffering from electric shock in a “conspicuous place” as per CEA Regulation 28.</p> <p>3. It is recommended to affix Danger notice in a conspicuous position in Hindi or English and local language of the district with sign of skull and bones of a design having IS2551 as per CEA Regulation 18.</p> <p>4. It is recommended to prepare and affix Electrical Single Line Diagram near electrical installation as per NEC 2023.</p> <p>5. It is recommended to affix tag on SFU/Cable for identification purpose along with directional arrows and its size on all cable as per NEC 2023.</p>

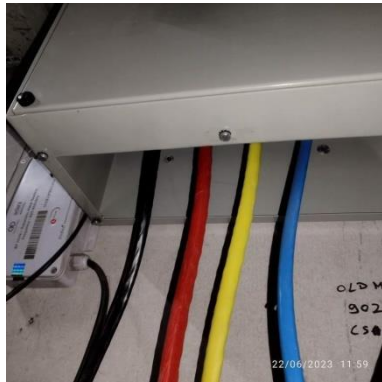
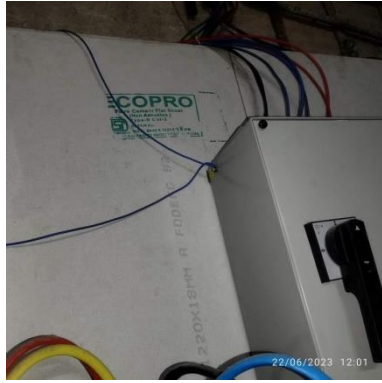
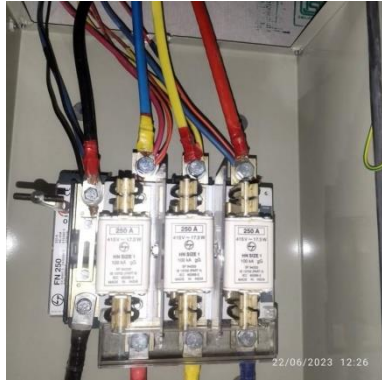
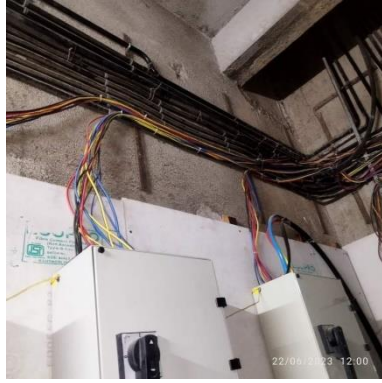
<p>6. Unwanted Material is Observed in electric meter room.</p> <p>7. MCB and Busbar Chamber are found open.</p> <p>8. SFU switch is found open from lower / upper side.</p> <p>9. Small size wire is used for body Earthing of SFU switch and DB.</p> <p>10. Multiple wires are directly connected at outgoing termination Point of SFU switch in adani electric meter room.</p> <p>11. Multiple outgoing wire observed from SFU switch without any protection.</p> <p>12. Dust is observed in SFU switch and DB</p>	<p>6. It is recommended to Remove unwanted material immediately from electric meter room.</p> <p>7. Provide enclosure cover for busbar board and MCB DB to prevent deposition of dust and unwanted tripping from insects.</p> <p>8. SFU switch is need to be enclosed properly from upper / lower side to prevent deposition of dust and unwanted tripping from insects.</p> <p>9. It is recommended to Provide 25*3 size GI earth strip for protective body Earthing to SFU switch and DB as Per IS3043.</p> <p>10. It is recommended to install rated size of ring type cu lugs on all circuit wiring and make all termination tight properly as per NEC 2023</p> <p>11. it is recommended to lay outgoing wire properly in PVC conduit pipe.</p> <p>12. Cleaning of panel shall be done at regular interval.</p>

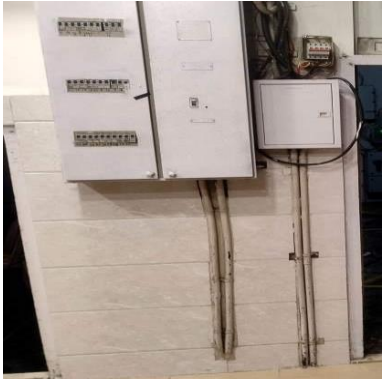
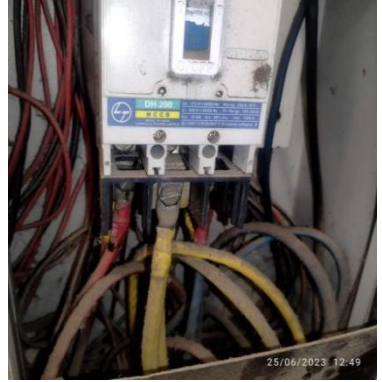
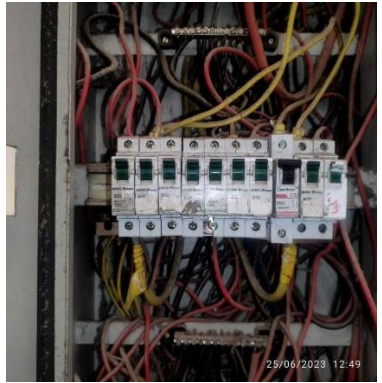
2	<p>Ground Floor Hall Electrical Panel</p>

<ol style="list-style-type: none"> 1. Tagging is not observed on all MCB for identification. 2. Danger Notice is not affixed on electrical panel and DB. 3. Insulation Rubber mat is not available in front of electrical installations. 4. Dust is observed in electric Panel. 5. Lugs are not observed on wire terminal of MCB. 6. Multiple wires are connected at SP MCB outgoing terminal. 	<ol style="list-style-type: none"> 1. It is recommended to affix tag on MCB for identification. 2. It is recommended to affix Danger notice in a conspicuous position in Hindi or English and local language of the district with sign of skull and bones of a design having IS2551 as per CEA Regulation 18. 3. It is recommended to place Insulation Rubber mat having IS 15652:2006 standard in front of electrical panel as per CEA Regulation19 (5). 4. Proper preventive maintenance is need to be carried out in electrical DB at regular interval. 5. It is recommended to install rated size of pin type cu lugs on all circuit wiring and make all termination tight properly as per NEC 2023. 6. It is recommended to connect one wire at MCB terminal to avoid overloading, loose connection and unwanted tripping on respective circuit.

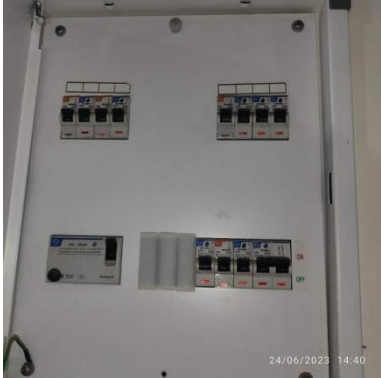
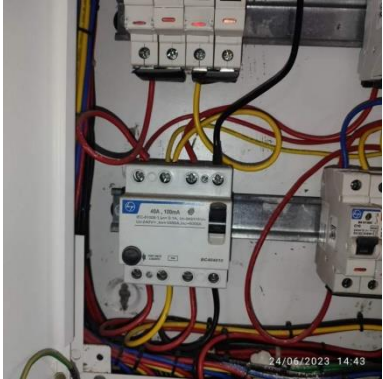
<p>6</p> <p>1st Floor Principle in charge office Electrical DB</p>

<p>1. Tagging is not observed on all MCB for identification.</p> <p>2. Lugs are not observed on wire terminal of MCB.</p>	<p>1. It is recommended to affix tag on MCB for identification.</p> <p>2. It is recommended to install rated size of pin type cu lugs on all circuit wiring and make all termination tight properly as per NEC 2023.</p>
<p>7</p> <p>1st Floor Room No- 112 Electrical DB'</p>

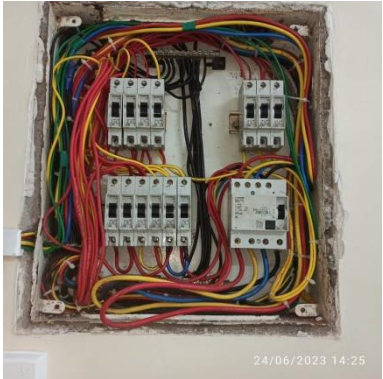
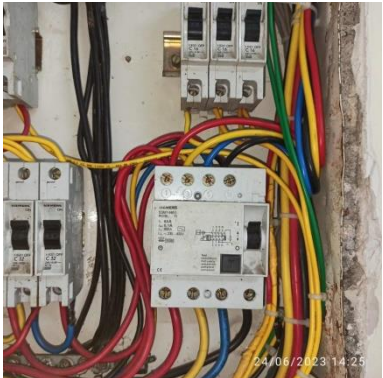
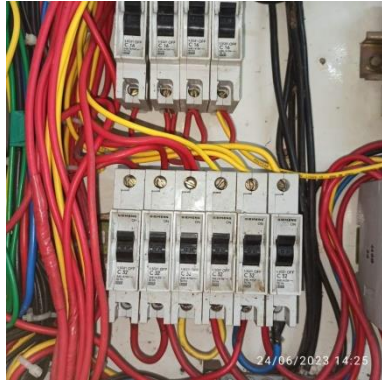
<p>1. Looping is observed on SP MCB.</p> <p>2. Lugs are not observed on wire terminal of MCB.</p>	<p>1. Looping are need to be removed and connect rated size of copper shorting link at SP MCB incomer.</p> <p>2. It is recommended to install rated size of pin type cu lugs on all circuit wiring and make all termination tight properly as per NEC 2023.</p>

<p>3. Multiple wires are connected at SP MCB outgoing terminal.</p>	<p>3. It is recommended to connect one wire at MCB terminal to avoid overloading, loose connection and unwanted tripping on respective circuit.</p>
<p>8</p>	<p>1st Floor Room No- 113 Electric Shaft</p>

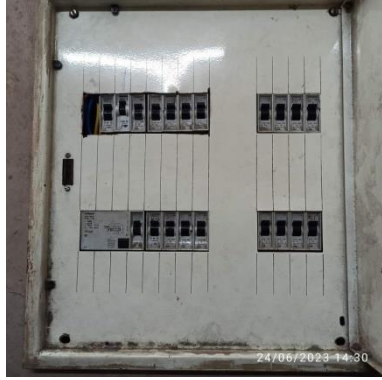
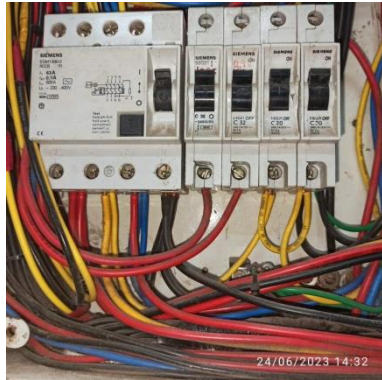
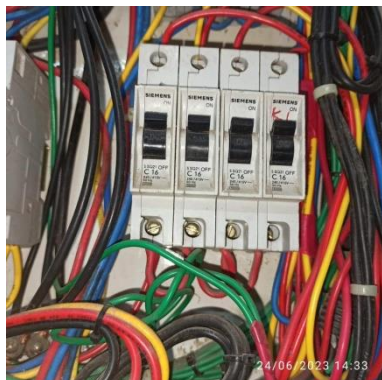
<p>1. Tagging is not observed on all MCB for identification.</p> <p>2. Dust is observed in electric DB.</p> <p>3. Lugs are not observed on wire terminal of MCB.</p> <p>4. Looping is observed on SP MCB.</p>	<p>1. It is recommended to affix tag on MCB for identification.</p> <p>2. Proper preventive maintenance is need to be carried out in electrical DB at regular interval.</p> <p>3. It is recommended to install rated size of pin type cu lugs on all circuit wiring and make all termination tight properly as per NEC 2023.</p> <p>4. Looping are need to be removed and connect rated size of copper shorting link at SP MCB incomer</p>

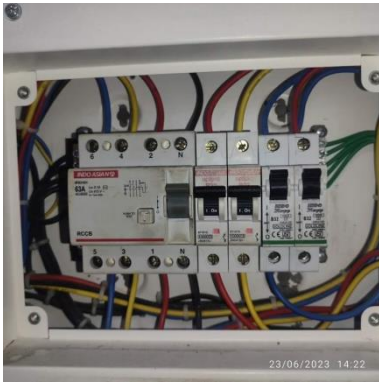
<p>22</p> <p>4th Floor Room No- 401 Electrical DB</p>

<p>1. Lugs are not observed on wire terminal of RCCB and MCB.</p>	<p>1. It is recommended to install rated size of pin type cu lugs on all wires and make all termination tight properly as per NEC 2023</p>
<p>23</p> <p>4th Floor Room No- 413 Electrical DB</p>

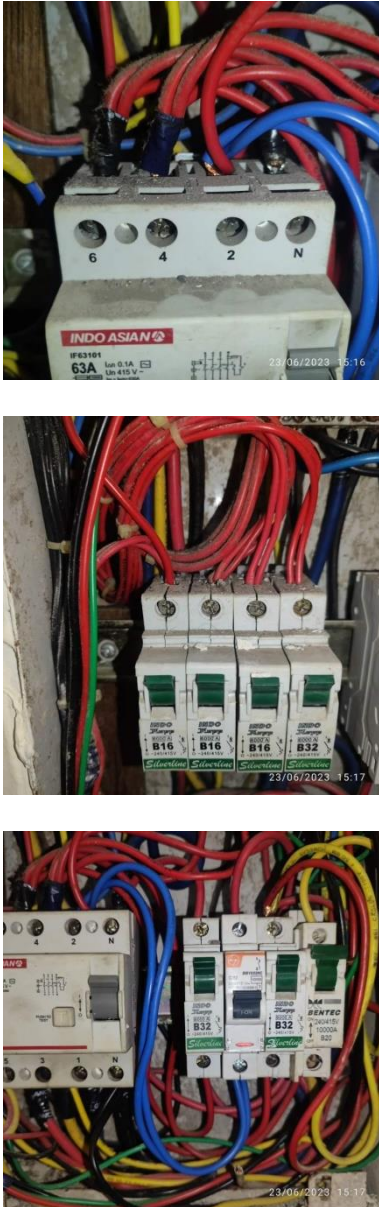
<p>1. Lugs are not observed on wire terminal of RCCB and MCB.</p> <p>2. Dust is observed in electric DB.</p> <p>3. Multiple wires are connected at SP MCB outgoing terminal.</p>	<p>1. It is recommended to install rated size of pin type cu lugs on all circuit wiring and make all termination tight properly as per NEC 2023.</p> <p>2. Proper preventive maintenance is need to be carried out in electrical DB at regular interval.</p> <p>3. It is recommended to connect one wire at SP MCB to avoid overloading, loose connection and unwanted tripping on respective circuit.</p>

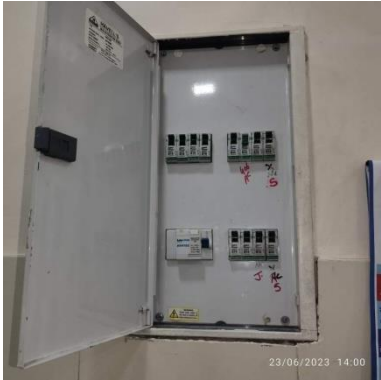
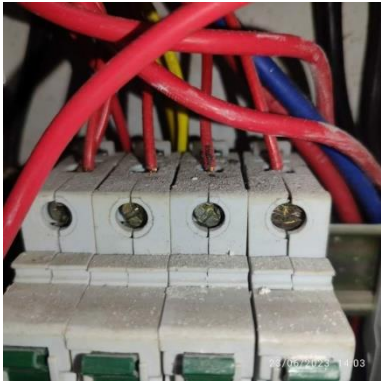
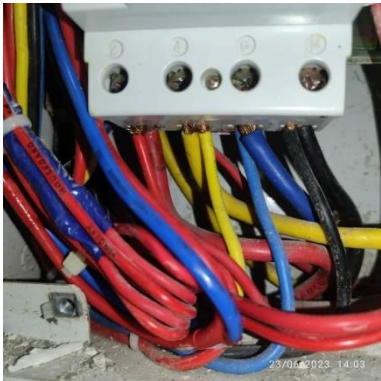
<p>24</p>	<p>4th Floor Room No- 412 Electrical DB</p>

<p>1. Tagging is not observed on all MCB for identification.</p> <p>2. Dust is observed in electric DB.</p> <p>3. Lugs are not observed on wire terminal of MCB.</p>	<p>1. It is recommended to affix tag on MCB for identification.</p> <p>2. Proper preventive maintenance is need to be carried out in electrical DB at regular interval.</p> <p>3. It is recommended to install rated size of pin type cu lugs on all circuit wiring and make all termination tight properly as per NEC 2023.</p>
<p>25</p>	<p>5th Floor Room No- 512 Electrical DB</p>

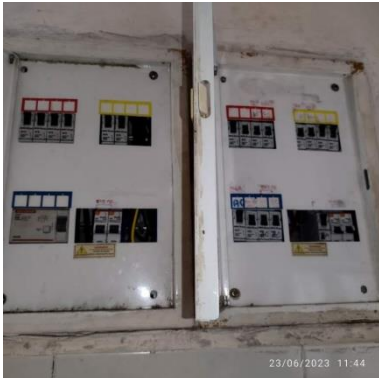
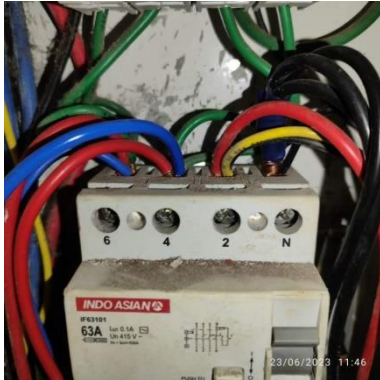
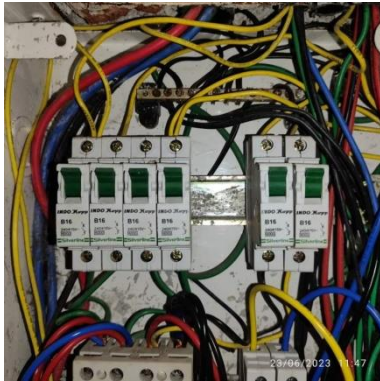
<p>1. Proper tagging is not observed on all MCB for identification.</p>	<p>1. It is recommended to affix tag on MCB for identification.</p>

<p>2. Multiple wires are connected at RCB outgoing terminal.</p> <p>3. Dust is observed in electric DB.</p> <p>4. Lugs are not observed on wire terminal of MCB.</p>	<p>2. It is recommended to connect one wire at RCB terminal to avoid overloading, loose connection and unwanted tripping on respective circuit.</p> <p>3. Proper preventive maintenance is need to be carried out in electrical DB at regular interval.</p> <p>4. It is recommended to install rated size of pin type cu lugs on all circuit wiring and make all termination tight properly as per NEC 2023.</p>
<p>27</p>	<p>6th Floor Room No- 612 Electrical DB</p>

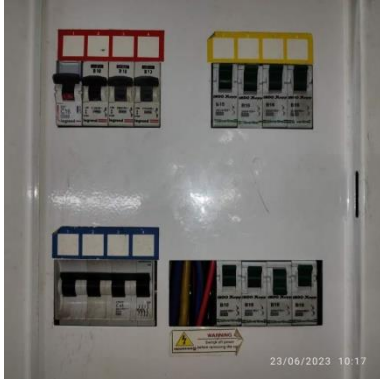
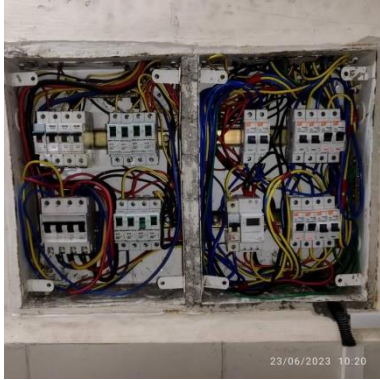
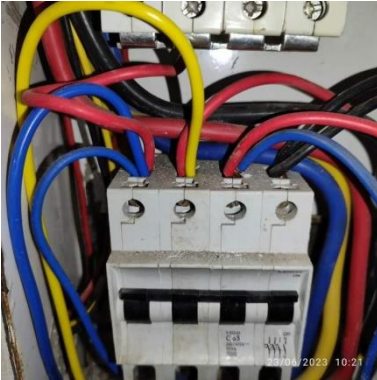
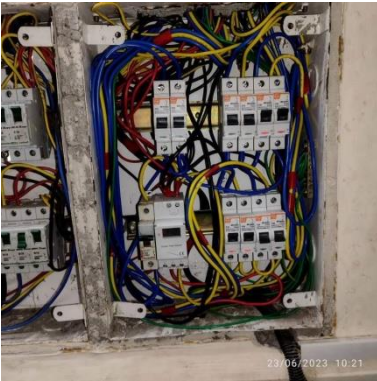
<p>1. Tagging is not observed on all MCB for identification.</p> <p>2. Dust is observed in electric DB.</p> <p>3. Multiple wires are connected at RCB outgoing terminal.</p>	<p>1. It is recommended to affix tag on MCB for identification.</p> <p>2. Proper preventive maintenance is need to be carried out in electrical DB at regular interval.</p> <p>3. It is recommended to connect one wire at MCB terminal to avoid overloading, loose connection and unwanted tripping on respective circuit.</p>

<p>4. Lugs are not observed on wire terminal of MCB.</p> <p>5. Looping is observed on SP MCB.</p>	<p>4. It is recommended to install rated size of pin type cu lugs on all circuit wiring and make all termination tight properly as per NEC 2023.</p> <p>5. Looping are need to be removed and connect rated size of copper shorting link at SP MCB incomer</p>
<p>28</p>	<p>6th Floor Room No- 613 Electrical DB</p>

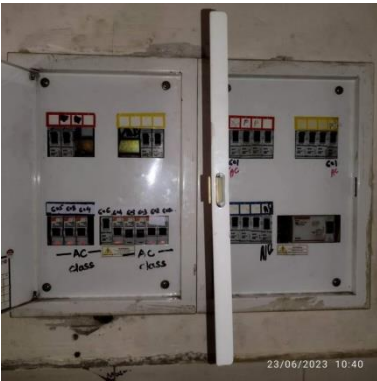
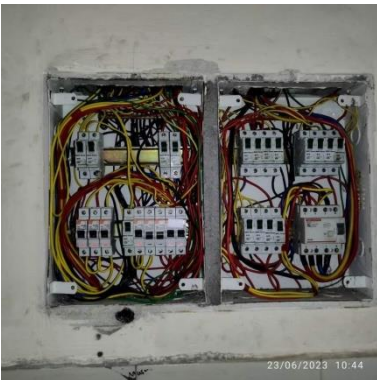
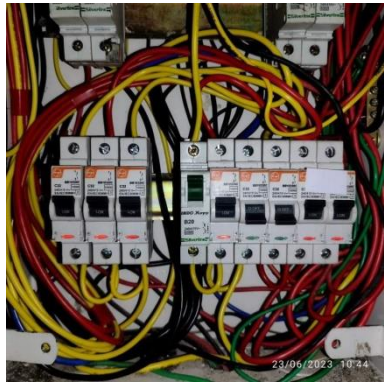
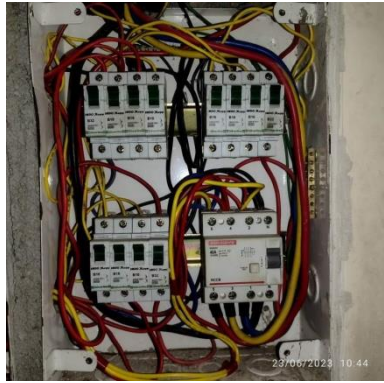
<p>1. Tagging is not observed on all MCB for identification.</p> <p>2. Dust is observed in electric DB.</p> <p>3. Lugs are not observed on wire terminal of MCB.</p>	<p>1. It is recommended to affix tag on MCB for identification.</p> <p>2. Proper preventive maintenance is need to be carried out in electrical DB at regular interval.</p> <p>3. It is recommended to install rated size of pin type cu lugs on all circuit wiring and make all termination tight properly as per NEC 2023.</p>

<p>4. Looping is observed on SP MCB.</p> <p>5. Multiple wires are connected at RCCB outgoing terminal.</p>	<p>4. Looping are need to be removed and connect rated size of copper shorting link at SP MCB incomer</p> <p>5. It is recommended to connect one wire at RCCB terminal to avoid overloading, loose connection and unwanted tripping on respective circuit.</p>
<p>29</p>	<p>6th, 7th and 8th Floor Electric Shaft</p>

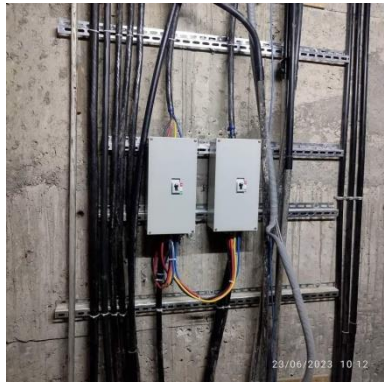
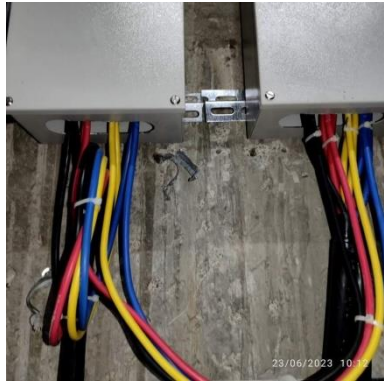
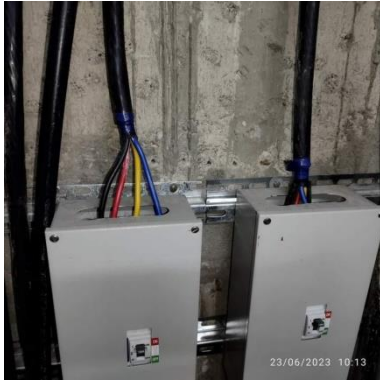
<p>1. MCCB enclosure are not enclosed properly from upper and lower side.</p> <p>2. Protective earth conductor is Not connected to MCCB enclosure.</p> <p>3. Tagging on all cables and on main incomer for identification is not available.</p>	<p>1. It is recommended to enclosed MCCB properly.</p> <p>2. It is recommended to provide and install 16sqmm size protective earth conductor to MCCB enclosure Body as Per IS3043.</p> <p>3. It is recommended to affix tag on cable for identification purpose along with directional arrows and its size on all cable as per NEC 2023.</p>

4. Insulation Rubber mat is not available in front of MCCB.	4. It is recommended to place Insulation Rubber mat having IS 15652:2006 standard in front of electrical panel as per CEA Regulation19 (5).
30	7 th Floor Electric Shaft

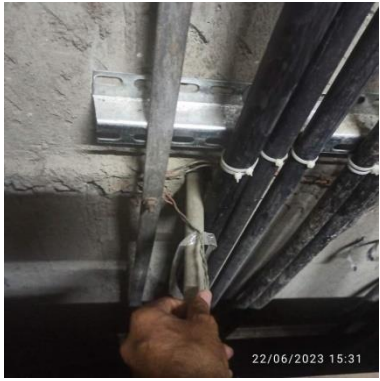
1. Protective earth conductor is not connected properly at earth strip.	1. Protective earth conductor of rated size is need to be connect properly at earth strip as per IS3043.
31	7 th Floor Room No-713 Electrical DB

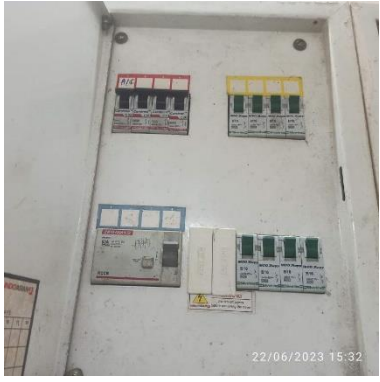
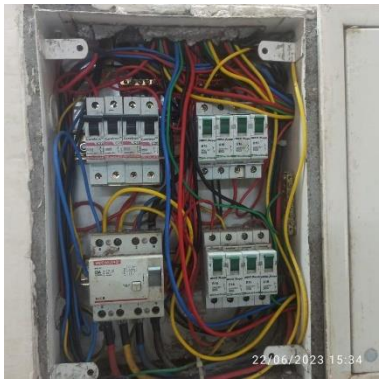
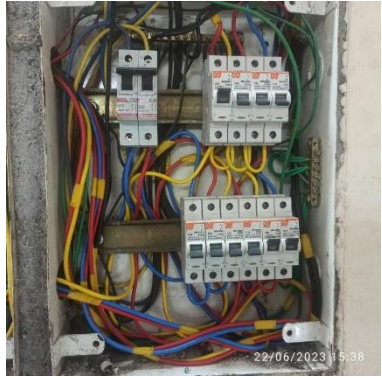
1. Tagging is not observed on all MCB for identification. 2. Dust is observed in electric DB. 3. Lugs are not observed on wire terminal of MCB. 4. Multiple wires are connected at RCCB outgoing terminal.	1. It is recommended to affix tag on MCB for identification. 2. Proper preventive maintenance is need to be carried out in electrical DB at regular interval. 3. It is recommended to install rated size of pin type cu lugs on all circuit wiring and make all termination tight properly as per NEC 2023. 4. It is recommended to connect one wire at RCCB terminal to avoid overloading, loose connection and unwanted tripping on respective circuit.

<p>5. Looping is observed on SP MCB.</p>	<p>5. Looping are need to be removed and connect rated size of copper shorting link at SP MCB incomer</p>
<p>32</p>	<p>7th Floor Room No- 712 Electrical DB</p>

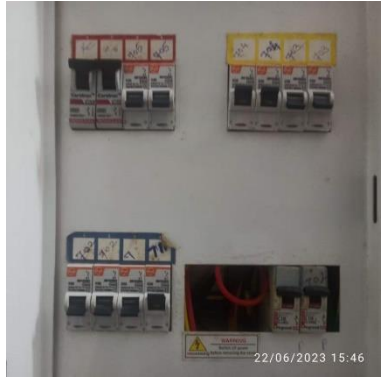
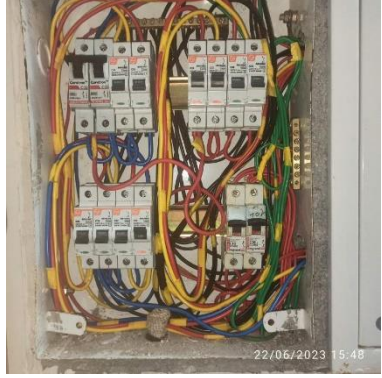
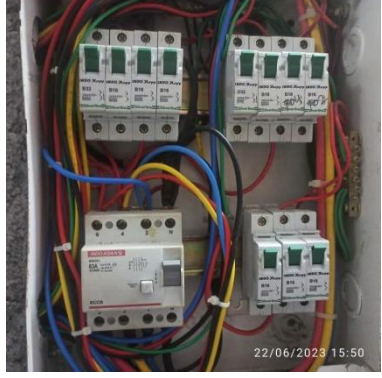
<p>1. Tagging is not observed on all MCB for identification.</p> <p>2. Dust is observed in electric DB.</p> <p>3. Lugs are not observed on wire terminal of MCB.</p> <p>4. Multiple wires are connected at RCCB outgoing terminal.</p> <p>5. Looping is observed on SP MCB.</p>	<p>1. It is recommended to affix tag on MCB for identification.</p> <p>2. Proper preventive maintenance is need to be carried out in electrical DB at regular interval.</p> <p>3. It is recommended to install rated size of pin type cu lugs on all circuit wiring and make all termination tight properly as per NEC 2023.</p> <p>4. It is recommended to connect one wire at RCCB terminal to avoid overloading, loose connection and unwanted tripping on respective circuit.</p> <p>5. Looping are need to be removed and connect rated size of copper shorting link at SP MCB incomer</p>

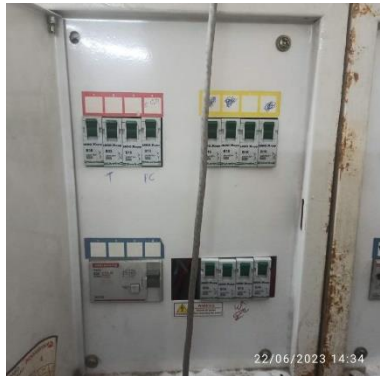
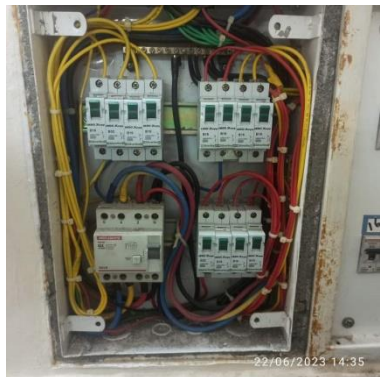
<p>33</p> <p>8th Floor Room No- 813 Electrical DB</p>

<ol style="list-style-type: none"> 1. Tagging is not observed on all MCB for identification. 2. Dust is observed in electric DB. 3. Lugs are not observed on wire terminal of MCB. 	<ol style="list-style-type: none"> 1. It is recommended to affix tag on MCB for identification. 2. Proper preventive maintenance is need to be carried out in electrical DB at regular interval. 3. It is recommended to install rated size of pin type cu lugs on all circuit wiring and make all termination tight properly as per NEC 2023.
<p>34</p> <p>8th Floor Room No- 812 Electrical DB</p>

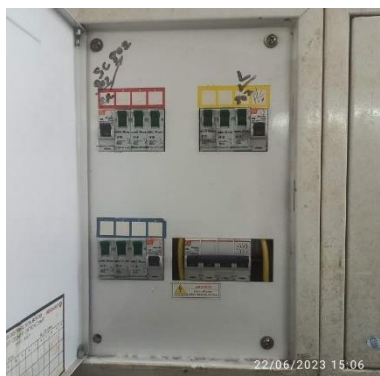
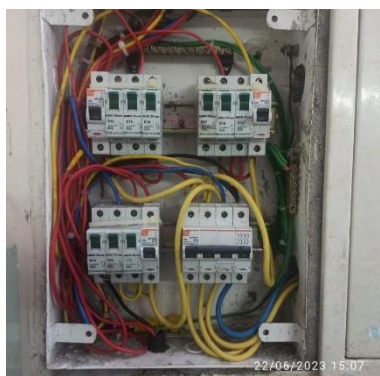
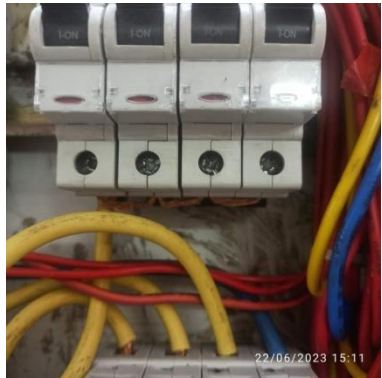
<ol style="list-style-type: none"> 1. Tagging is not observed on all MCB for identification. 2. Dust is observed in electric DB. 3. Lugs are not observed on wire terminal of MCB. 4. Multiple wires are connected at RCCB outgoing terminal. 	<ol style="list-style-type: none"> 1. It is recommended to affix tag on MCB for identification. 2. Proper preventive maintenance is need to be carried out in electrical DB at regular interval. 3. It is recommended to install rated size of pin type cu lugs on all circuit wiring and make all termination tight properly as per NEC 2023. 4. It is recommended to connect one wire at RCCB terminal to avoid overloading, loose connection and unwanted tripping on respective circuit.

<p>5. Looping is observed on SP MCB.</p>	<p>5. Looping are need to be removed and connect rated size of copper shorting link at SP MCB incomer</p>
<p>35</p>	<p>Lift room</p>

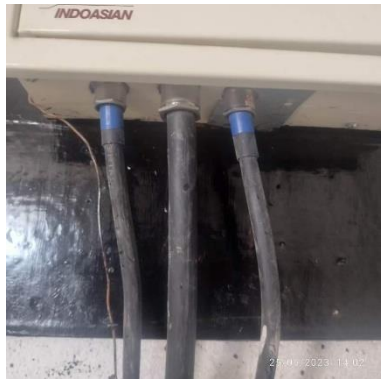
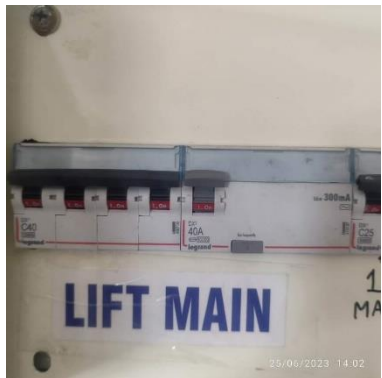
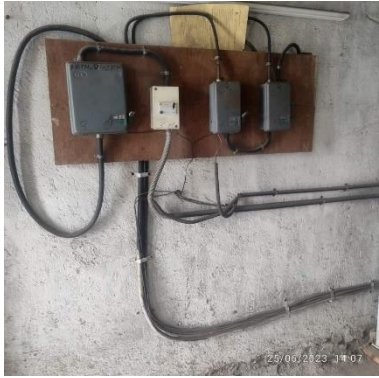
<p>1. Insulation Rubber mat is not available in front of electrical installations.</p> <p>2. Proper Tagging on all SFU switch/Cable is not provided for identification.</p> <p>3. Display of Instructions chart for resuscitation of persons suffering from electric shock is not affix in electrical meter room.</p> <p>4. Danger Notice is not affixed on electrical panel and DB.</p>	<p>1. It is recommended to place Insulation Rubber mat having IS 15652:2006 standard in front of electrical panel as per CEA Regulation19 (5).</p> <p>2. It is recommended to affix tag on SFU/Cable for identification purpose along with directional arrows and its size on all cable as per NEC 2023.</p> <p>3. It is recommended to affix display of Instructions for resuscitation of persons suffering from electric shock in a “conspicuous place” as per CEA Regulation 28.</p> <p>4. It is recommended to affix Danger notice in a conspicuous position in Hindi or English and local language of the district with sign of skull and bones of a design having IS2551 as per CEA Regulation 18.</p>

<p>5. Electrical Single line diagram of electrical installation is not available near electrical panel/DB.</p> <p>6. Unwanted Material is Observed in lift room.</p>	<p>5. It is recommended to prepare and affix Electrical Single Line Diagram near electrical installation as per NEC 2023.</p> <p>6. It is recommended to Remove unwanted material immediately from lift room.</p>
36	Electrical meter room

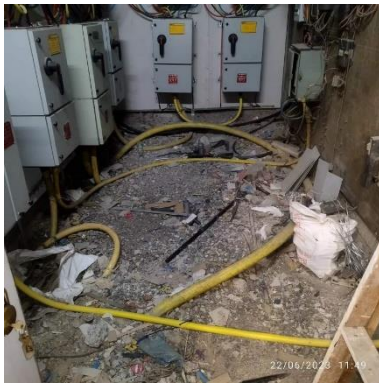
<p>1. Main LT cables are laid on floor in Electrical meter room haphazardly and there is no any proper platform in electrical meters/ switchgear to perform any electrical operation and maintenance activity in easy or convenient way. Also supplier's earth is also provided in same meter room without any chamber cover.</p>	<p>1. It is recommended to make proper platform in Electrical meter room, so electrician can do their electrical maintenance activity with safety.</p>
37	Terrace area

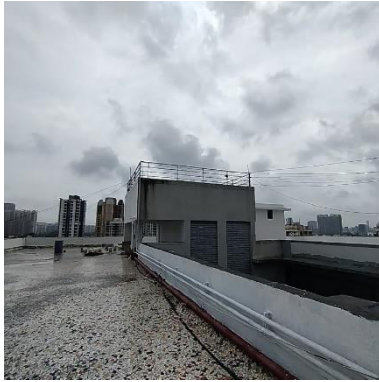
<p>1. Lightning Arrestor is not available on terrace area as per NEC 2023.</p> <p>2. Surge Protection Device is not observed in Electrical installation to provide protection against lightning strike or voltage surge as per NEC 2023/ IS 732.</p>	<p>1. It is recommended to provide Lightning Arrestor on terrace for providing protection against lightning strike.</p> <p>Provide proper equipotential bonding arrangement as per IS 732, NEC 2023, IS 3043.</p> <p>2. It is recommended to provide rated size of Surge Protection Device (SPD) in each Electricity meter distribution side as per code of practice strictly to perform its operation as per IS 732, NEC2023.</p>
