ELECTRICAL SAFETY AUDIT
JUNE 2023

FOR
NIRMALA MEMORIAL
FOUNDATION,
KANDIVALI

Prepared by
M/s. ETCOM ENGINEERING
SERVICES

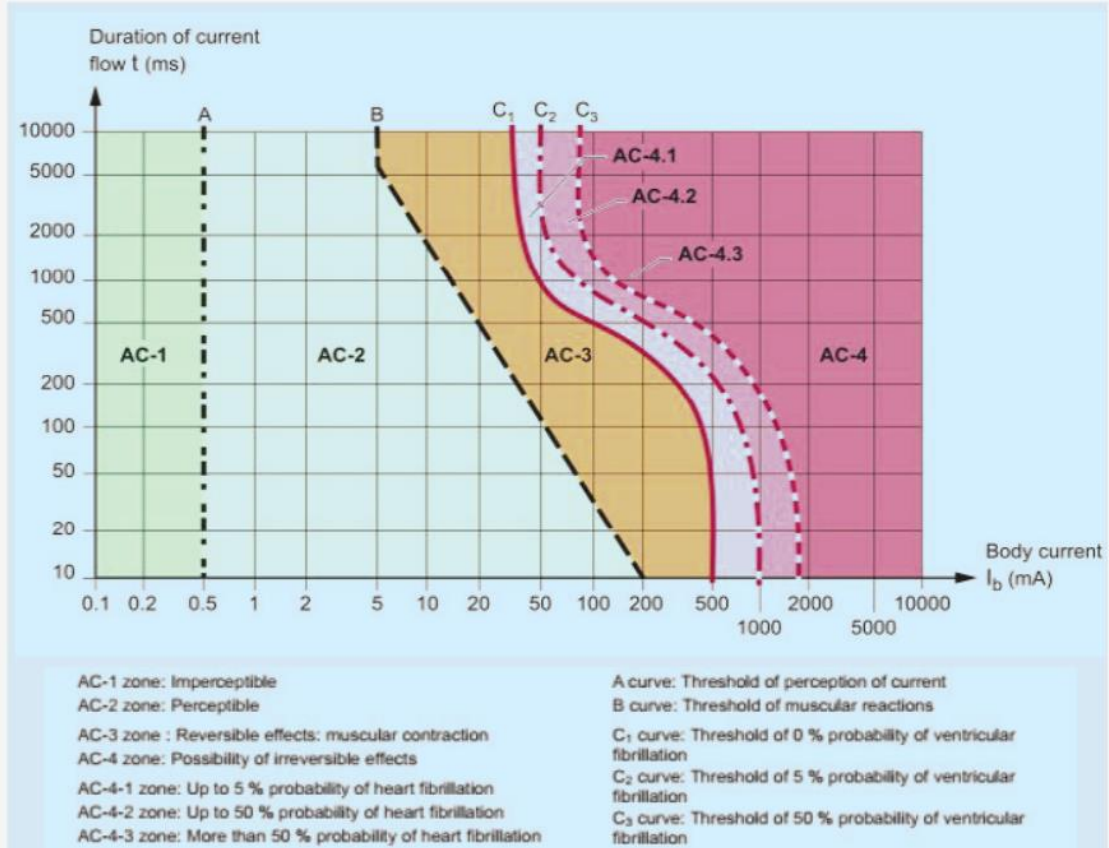
FIG. A-1 PATHOPHYSIOLOGICAL EFFECTS IN FOUR ZONES OF CURRENT-MAGNITUDE/TIME-DURATION

Above fig Annex A of NEC 2023 well explains about why owner should install RCD not exceeding 30mA rated residual current capacity.

As per **Section 10 Protection against electric shock of NEC 2023** it is recommended to install RCD in all Distribution Boards not exceeding 30mA rated residual current capacity for providing protection against electric shock of **suitable category** only.

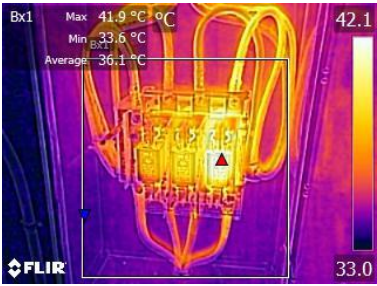
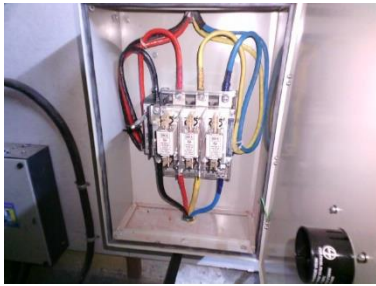
10	8 th floor Main SFU incomer

<p>Observation: Maximum temperature observed on cable terminal of SFU is Bx1: 41.9 °C</p> <p>Recommendation: Found Ok.</p>
11	7 th floor Bus bar chamber

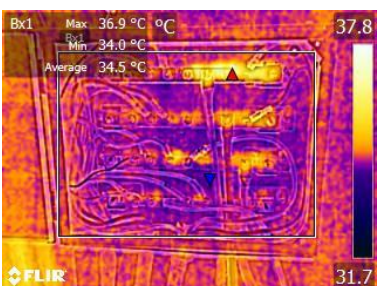
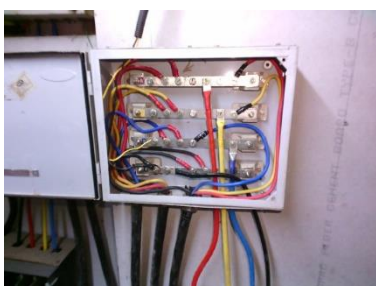
<p>Observation: Maximum temperature observed on cable terminal of bus bar is Bx1: 36.9 °C</p> <p>Recommendation: Found Ok.</p>
12	6 th floor bus bar chamber

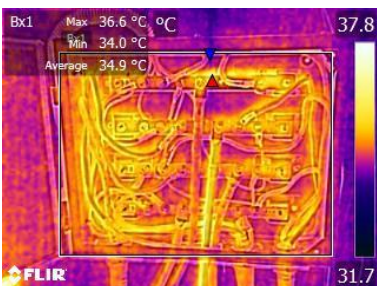
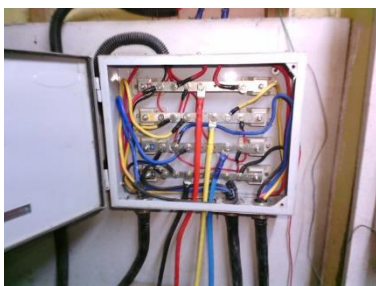
<p>Observation: Maximum temperature observed on cable terminal of Bus bar is Bx1: 36.6 °C</p> <p>Recommendation: Found Ok.</p>
13	6 th floor Main SFU incomer

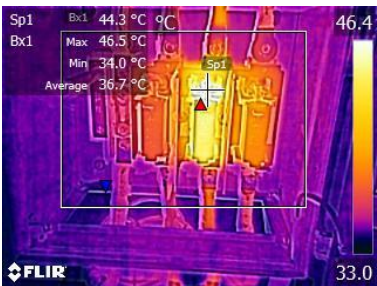
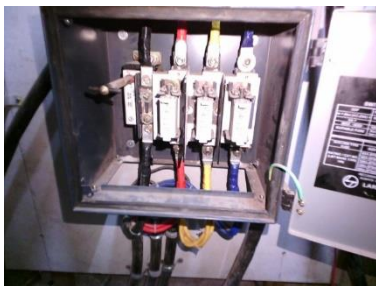
<p>Observation: Maximum temperature observed on cable terminal of SFU is Bx1: 44.3 °C</p> <p>Recommendation: It is recommended to fix HRC fuse properly in SFU switch and make proper connection.</p>
14	Ground floor Electrical panel

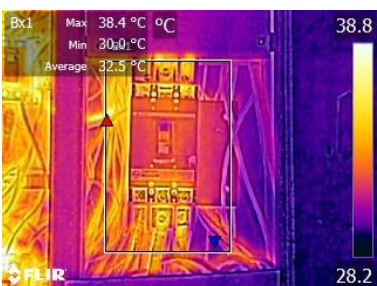
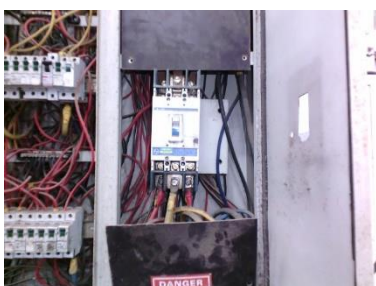
<p>Observation: Maximum temperature observed on cable terminal of MCCB is Bx1: 38.4 °C</p> <p>Recommendation: Found Ok.</p>

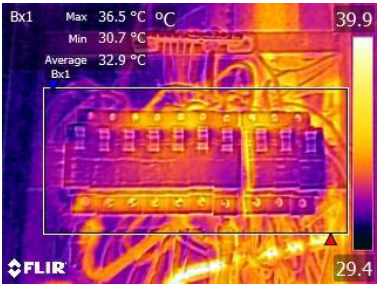
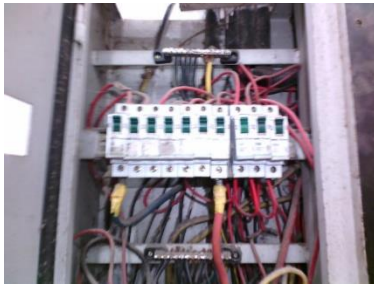
15	R-phase section of electrical panel

<p>Observation: Maximum temperature observed on cable terminal of MCB is Bx1: 36.5 °C</p> <p>Recommendation: Found Ok.</p>
16	Y-phase section of electrical panel

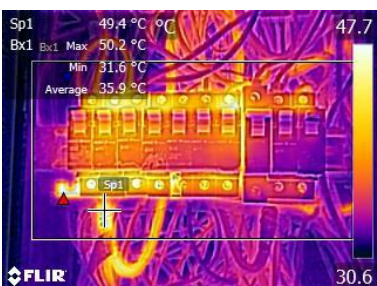
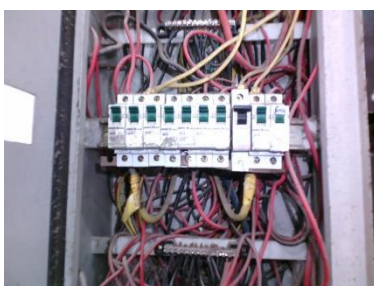
<p>Observation: Maximum temperature observed on incoming cable terminal of MCB is Bx1: 49.4 °C</p> <p>Recommendation: It is recommended to make proper tightening on cable at MCB terminal.</p>
17	B-phase section of electrical panel

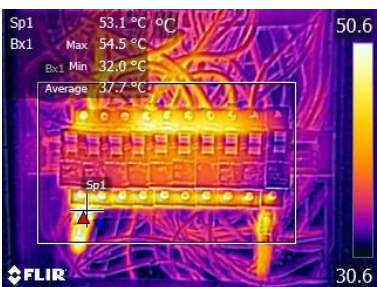
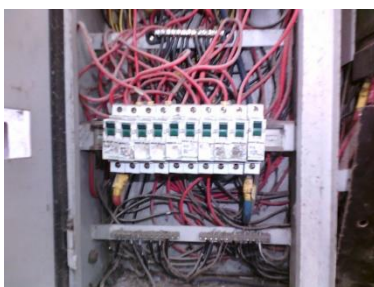
<p>Observation: Maximum temperature observed on incoming cable terminal of MCB is Bx1: 54.5 °C</p> <p>Recommendation: It is recommended to make proper tightening on cable at MCB terminal.</p>
18	1 st floor room no. 112

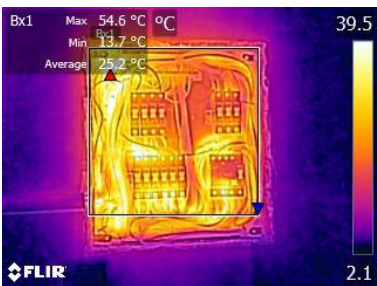
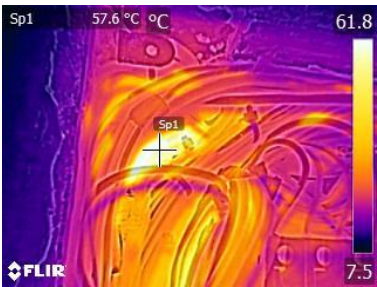
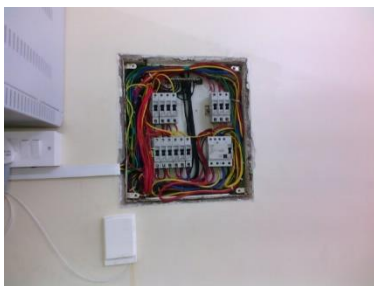
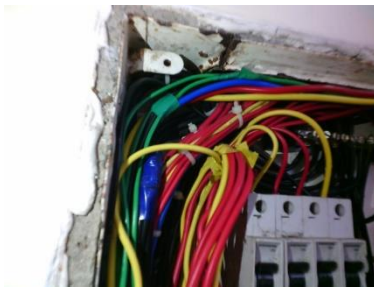
<p>Observation: Maximum temperature observed on neutral wire joint is Bx1:54.6 °C</p> <p>Sp1: 57.6 °C</p> <p>Recommendation: It is recommended to remove neutral wire joint. crimp rated size of LUGs on wire terminal</p>

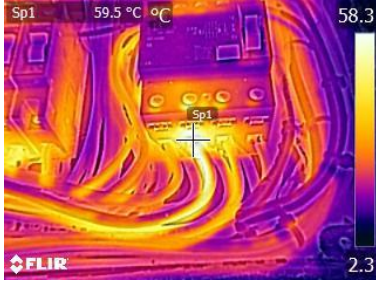
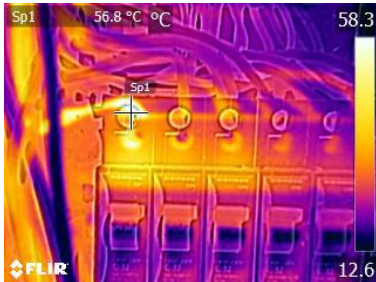
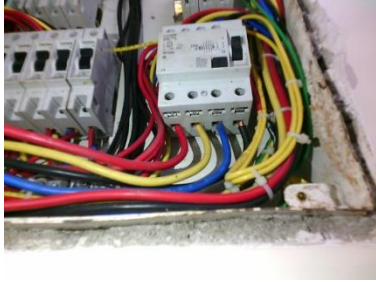
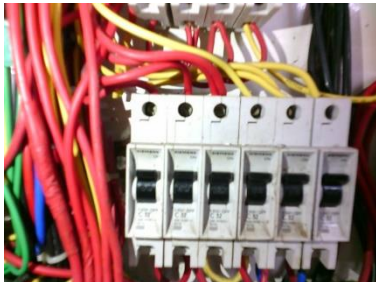
<p>and make proper tightening on wire neutral link.</p> <p>Observation: Maximum temperature observed on Y-phase wire terminal of RCCB is Bx1: 59.5 °C</p> <p>Recommendation: It is recommended to crimp rated size of LUGs on wire terminal and make proper tightening on wire terminal of RCCB.</p> <p>Observation: Maximum temperature observed on outgoing wire terminal of MCB is Sp1: 56.8 °C</p> <p>Recommendation: It is recommended to crimp rated size of LUGs on wire terminal and make proper tightening on wire terminal of MCB.</p>
19	1 st floor room no. 113

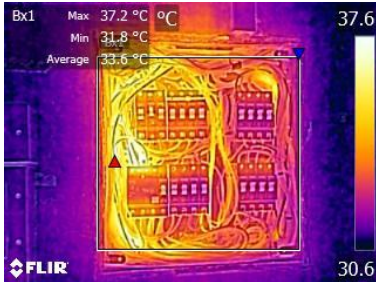
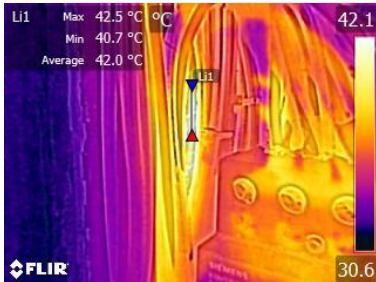
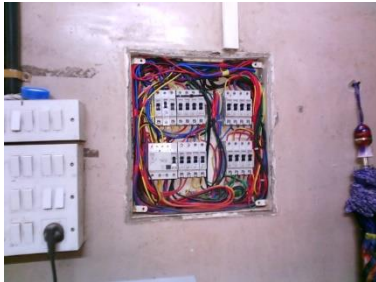
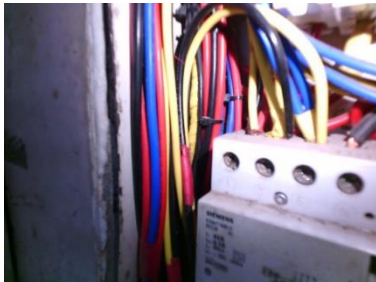
<p>Observation: Maximum temperature observed on wire joint is Bx1: 37.2 °C</p> <p>Li1: 42.5 °C</p> <p>Recommendation: It is recommended to remove wire joint. crimp rated size of LUGs on wire terminal and make proper tightening on wire at MCB terminal.</p>

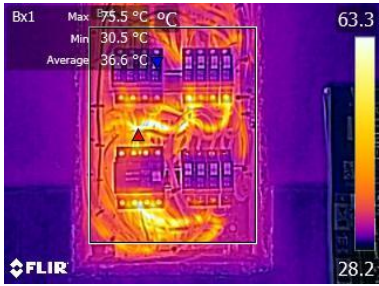
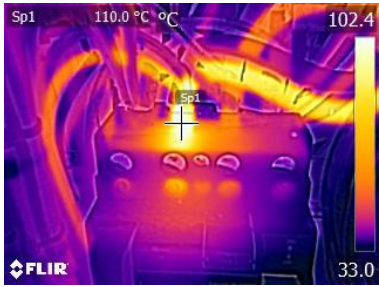
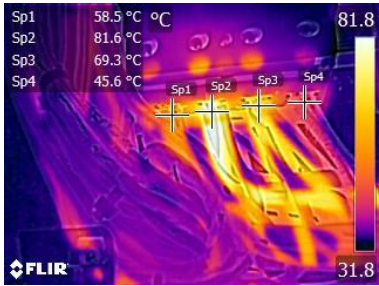
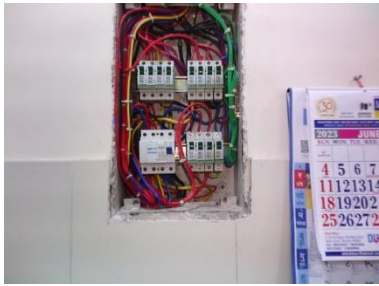
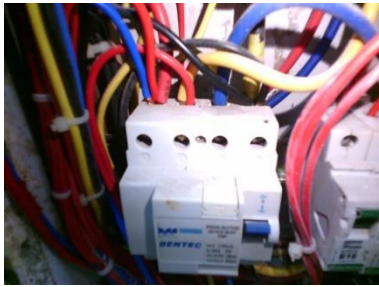
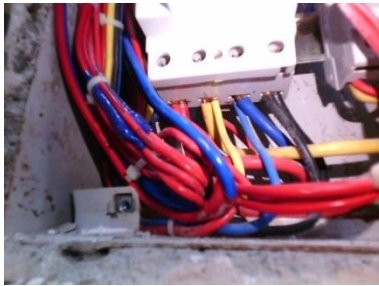
<p>39</p> <p>4th floor room no. 412 DB</p>

<p>Observation: Maximum temperature observed on Y-phase outgoing wire is Bx1: 75.5 °C</p> <p>Maximum temperature observed on Y-phase outgoing wire is Sp1: 110 °C</p> <p>Maximum temperature observed on incoming wire of RCCB is Sp1: 58.5 °C Sp2: 81.6 °C Sp3: 69.3 °C</p> <p>Recommendation: It is recommended to provide and install proper size wire to incoming wire of AC DB and crimp rated size of LUGs on wire terminal and make proper tightening on wire terminal of RCCB.</p>
<p>40</p> <p>4th floor room no. 413 DB</p>

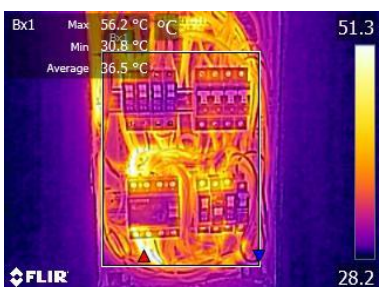
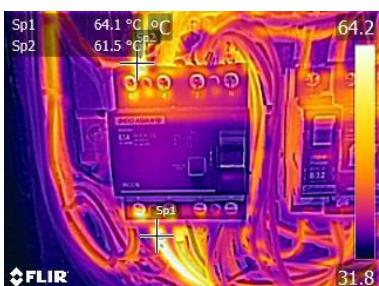
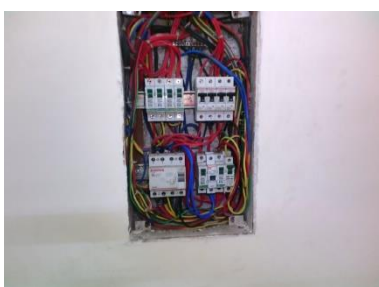
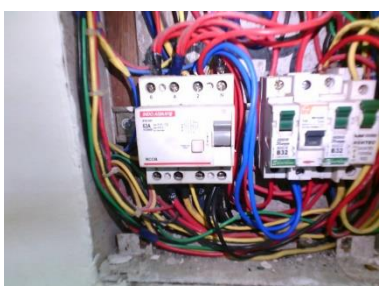
<p>Observation: Maximum temperature observed on incoming wire terminal of RCCB is Bx1: 56.2 °C</p> <p>Maximum temperature observed on R-phase outgoing wire is Sp1: 64.1 °C</p> <p>Maximum temperature observed on incoming wire of RCCB is Sp1: 80.2 °C</p>

<p>Recommendation: It is recommended to crimp rated size of LUGs on wire terminal and make proper tightening on wire terminal of RCCB.</p>
41	5 th floor room no. 512 LDB	 	 	<p>Observation: Maximum temperature observed on RCCB outgoing wire terminal is Bx1: 53.9 °C</p> <p>Observation: Maximum temperature observed on RCCB outgoing wire terminal is Li1: 61.6 °C</p> <p>Recommendation: It is recommended to provide and install proper size wire to outgoing wire of RCCB and crimp rated size of LUGs on wire terminal and make proper tightening on wire terminal of RCCB.</p>
42	5 th floor room no. 512 AC DB	 	 	<p>Observation: Maximum temperature observed on AC DB incoming wire is Bx1: 52.3 °C</p> <p>Observation: Maximum temperature observed on AC DB incoming wire is Li1: 52.8 °C</p> <p>Observation: Maximum temperature observed on AC DB</p>

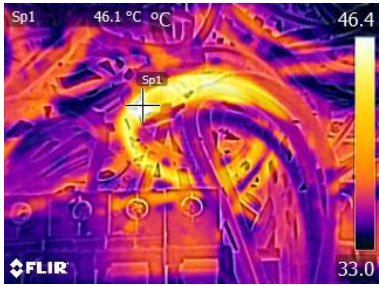
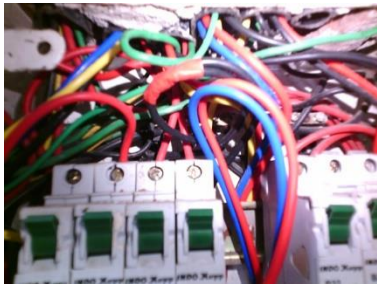
<p>45</p>	<p>5th floor room no. 513 AC DB</p>

<p>Observation: Maximum temperature observed on Neutral wire joint is Sp1: 46.1 °C</p> <p>Recommendation: It is recommended to remove wire joint and connect direct neutral wire on terminal.</p>
<p>46</p>	<p>Main MCCB of 6th floor</p>

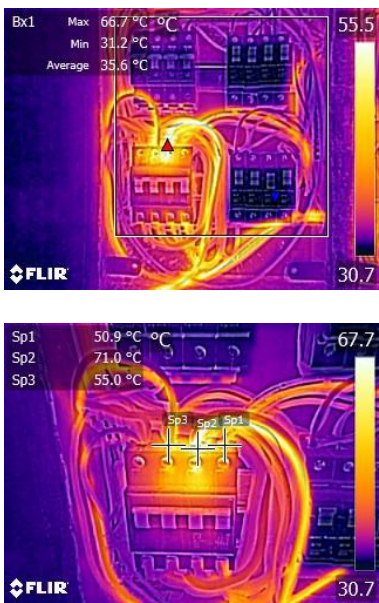
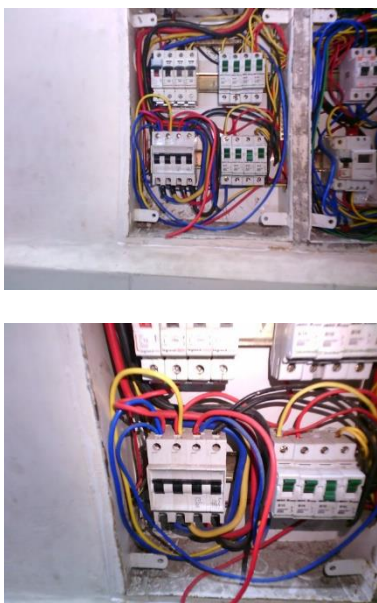
<p>Observation: Maximum temperature observed on MCB outgoing wire terminal is Bx1: 66.7 °C</p> <p>Observation: Maximum temperature observed on MCB outgoing wire terminal are Sp1: 50.9 °C Sp2: 71.0 °C Sp3: 55.0 °C</p> <p>Recommendation: It is recommended to provide and install</p>

<p>proper size wire to AC DB and crimp rated size of LUGs on wire terminal and make proper tightening on wire terminal of MCB.</p>
48	AC DB

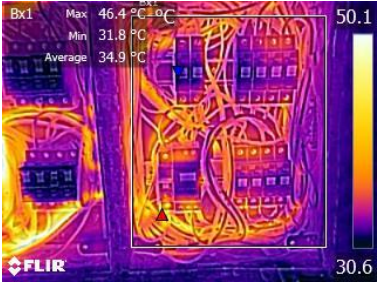
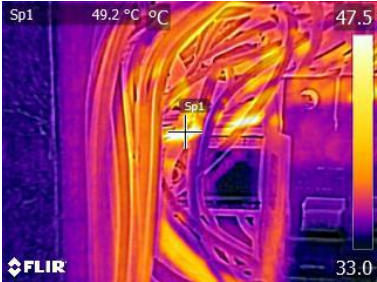
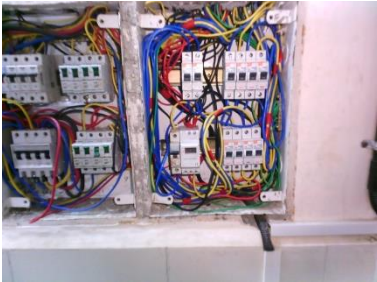
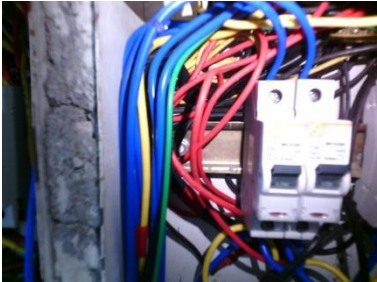
<p>Observation: Maximum temperature observed on MCB incoming wire terminal is Bx1: 46.4 °C</p> <p>Observation: Maximum temperature observed on incoming wire is Sp1: 49.2 °C</p> <p>Recommendation: It is recommended to provide and install proper size wire to AC DB and crimp rated size of LUGs on wire terminal and make proper tightening on wire terminal of MCB.</p>
49	6 th floor room no. 612 LDB

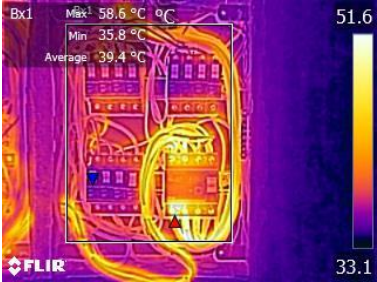
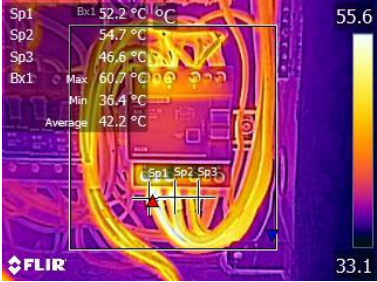
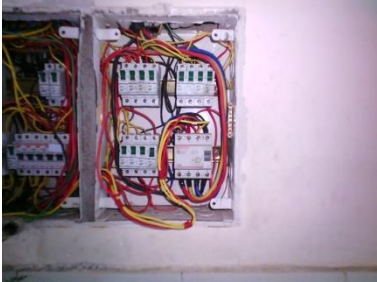
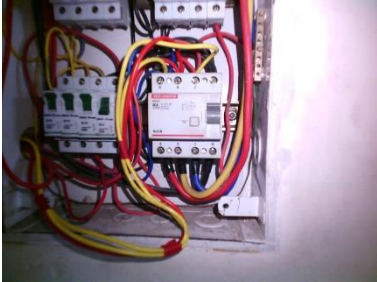
<p>Observation: Maximum temperature observed on RCCB incoming wire terminal is Bx1: 58.6 °C</p> <p>Observation: Maximum temperature observed on RCCB incoming wire terminal are Sp1: 52.2 °C Sp2: 54.7 °C Sp3: 46.6 °C</p> <p>Recommendation: It is recommended to make proper tightening on wire terminal of RCCB.</p>

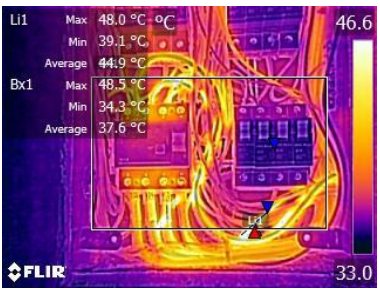
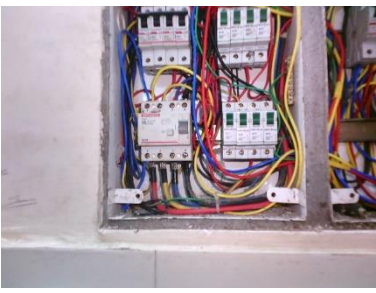
<p>Observation: Maximum temperature observed on AC DB outgoing wire is Bx1: 46.3 °C</p> <p>Recommendation: It is recommended to crimp rated size of LUGs on wire terminal and make proper tightening on wire terminal of MCB.</p>

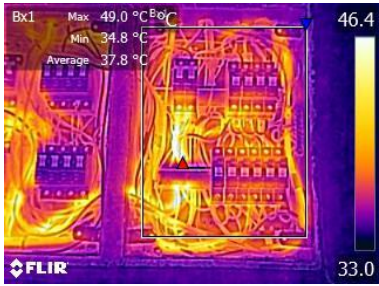
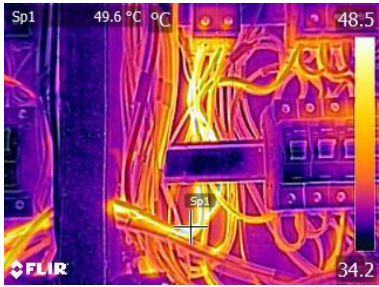
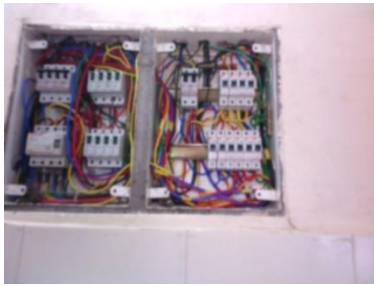
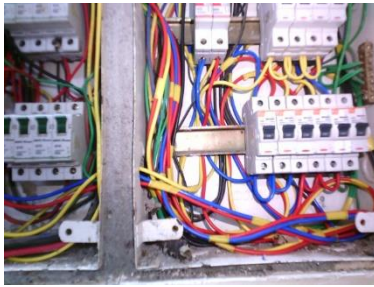
53	AC DB

<p>Observation: Maximum temperature observed on AC DB outgoing wire is Bx1: 49.0 °C</p> <p>Sp1: 49.6 °C</p> <p>Recommendation: It is recommended to replace the incomer wire of AC DB with 10sqmm wire and crimp rated size of LUG to wire terminal.</p>
54	7 th floor room no. 712 LDB

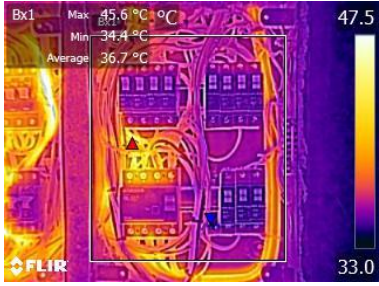
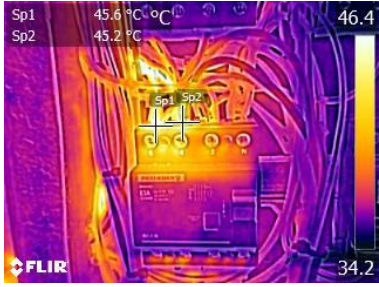
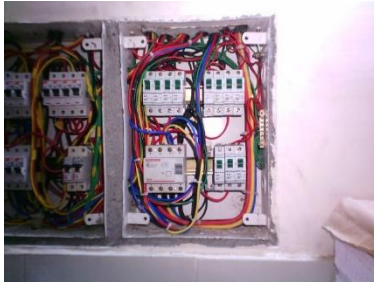
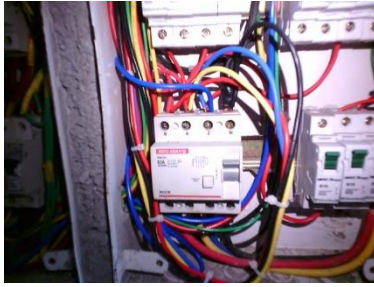
<p>Observation: Maximum temperature observed on MCB outgoing wire is Bx1: 45.6 °C</p> <p>Observation: Maximum temperature observed on MCB outgoing wire is Sp1: 45.6 °C Sp2: 45.2 °C</p> <p>Recommendation: It is recommended to crimp rated size of LUGs on wire terminal and make proper tightening on wire terminal of MCB.</p>
55	7 th floor room no. 712 AC DB

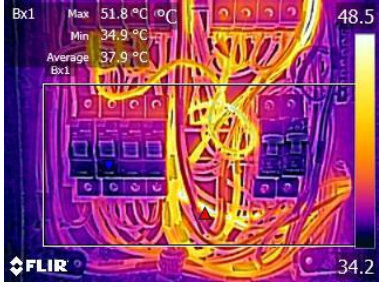
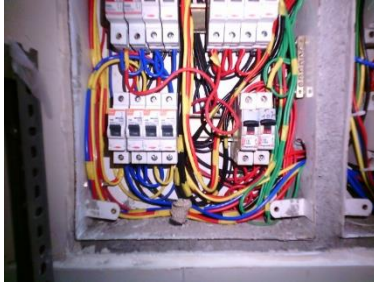
<p>Observation: Maximum temperature observed on AC DB outgoing wire is Bx1: 51.8 °C</p> <p>Recommendation: It is recommended to replace the incomer wire of AC DB with 10sqmm wire and crimp rated size of LUG to wire terminal.</p>

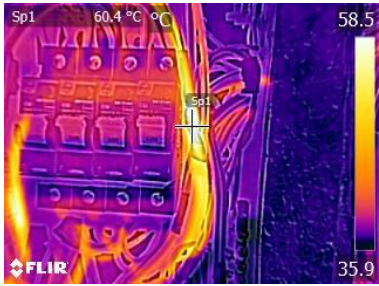
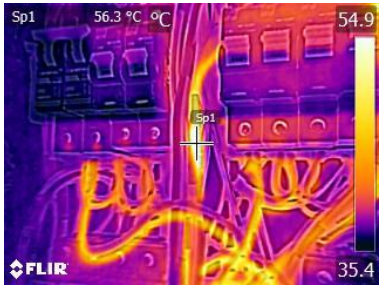
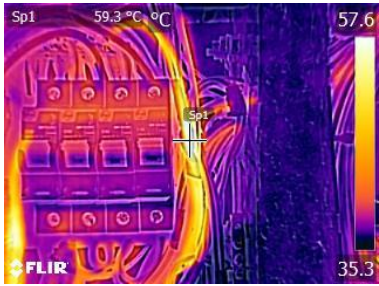
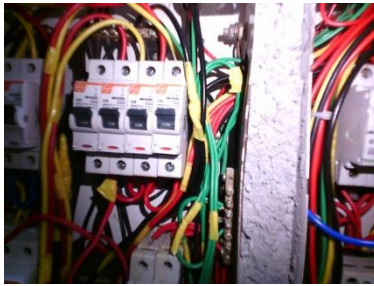
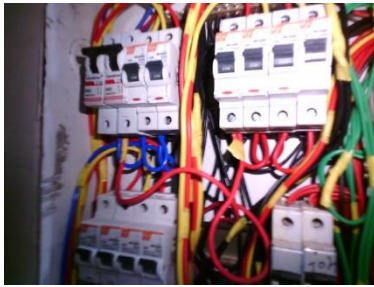
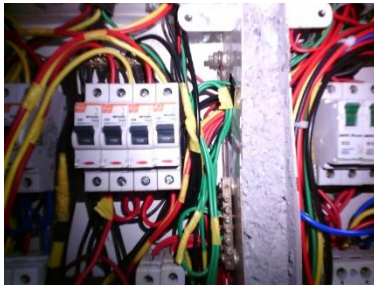
56	7 th floor room no. 712 AC DB

<p>Observation: Maximum temperature observed on Neutral wire joint is Sp1: 60.4 °C</p> <p>Sp1: 56.3 °C</p> <p>Sp1: 59.3 °C</p> <p>Recommendation: It is recommended to remove wire joint and connect direct neutral wire on terminal.</p>
57	Main MCCB of 8 th floor Library side DB

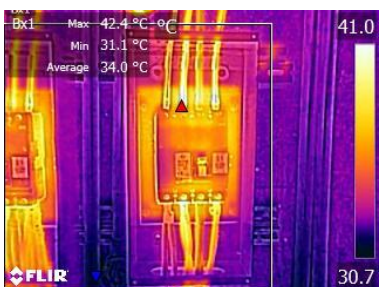
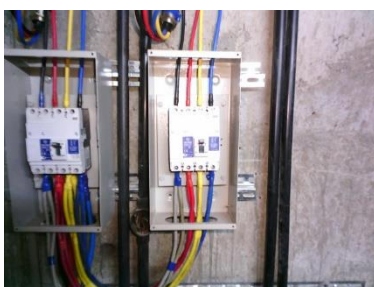
<p>Observation: Maximum temperature observed on R-phase outgoing cable terminals is Bx1: 42.4 °C</p> <p>Recommendation: Found OK</p>
58	LDB

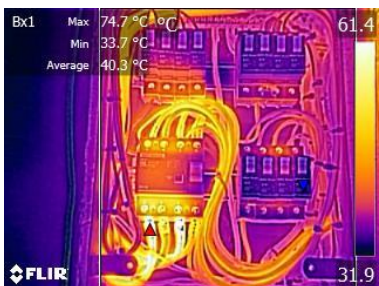
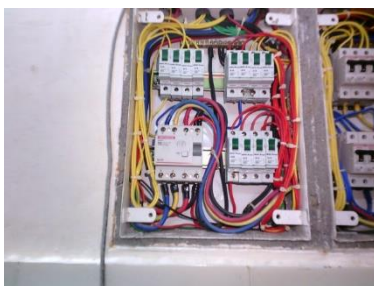
<p>Observation: Maximum temperature observed on MCB incoming wire terminals is Bx1: 74.7 °C</p>

<p>Observation: Maximum temperature observed on MCB incoming wire terminals is Bx1: 79.0 °C</p> <p>Observation: Maximum temperature observed on MCB outgoing wire terminals are Sp1: 49.6 °C Sp2: 52.4 °C Sp3: 58.7 °C</p> <p>Recommendation: Rated size of LUGs are need to be crimp on wire terminal and make proper tightening on wire terminal of MCB.</p>
59	AC DB

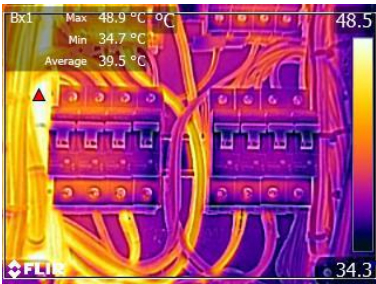
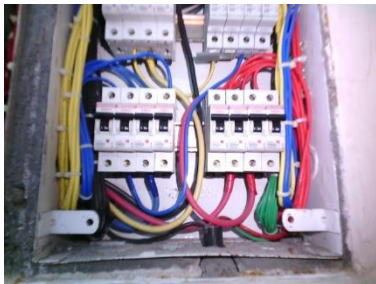
<p>Observation: Maximum temperature observed on incoming wire is Bx1: 48.9 °C</p> <p>Recommendation: It is recommended to replace the incomer wire of AC DB with 10sqmm wire and crimp rated size of LUG to wire terminal.</p>
60	Main MCCB of 8 th floor 812 side DB

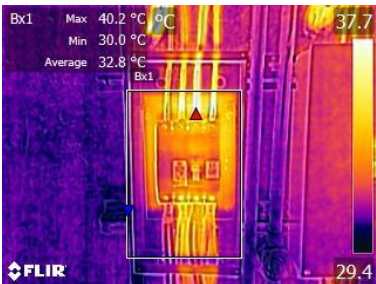
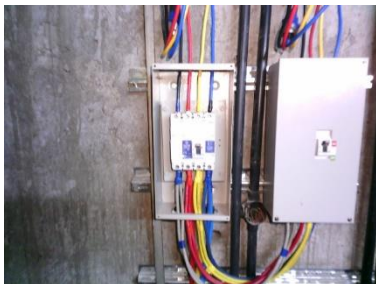
<p>Observation: Maximum temperature observed on Y-phase outgoing cable terminals is Bx1: 40.2 °C</p> <p>Recommendation: Found OK</p>

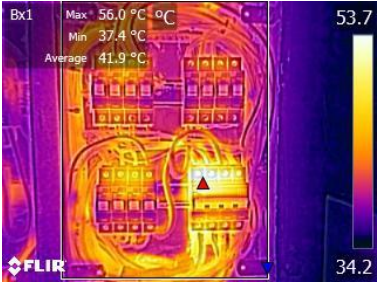
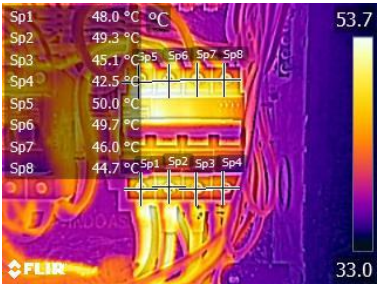
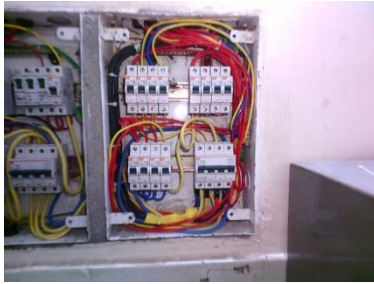
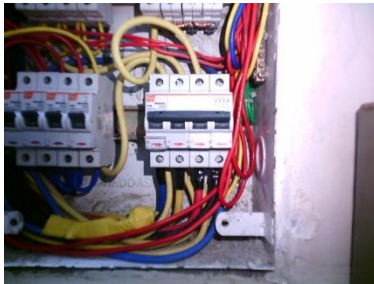
61	AC DB

<p>Observation: Maximum temperature observed on MCB outgoing terminals is Bx1: 56 °C</p> <p>Maximum temperature observed on MCB outgoing & incoming terminals are Sp1: 48 °C Sp2: 49.3 °C Sp3: 45.1 °C</p> <p>Recommendation: It is recommended to crimp rated size of LUGs on wire terminal and make proper tightening on wire terminal of MCB.</p>
62	LDB

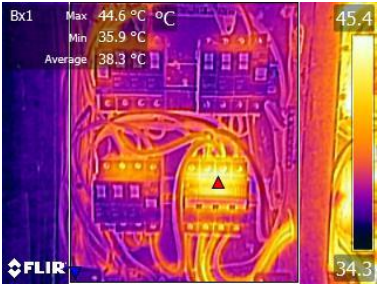
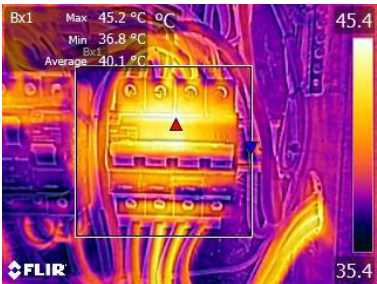
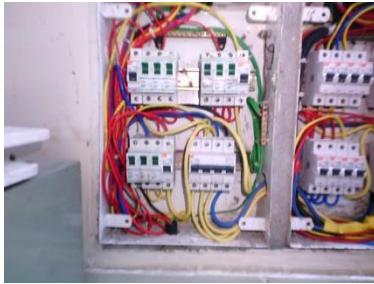
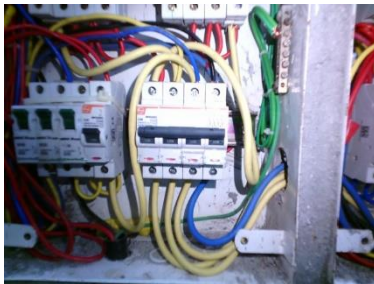
<p>Observation: Maximum temperature observed on MCB terminals is Bx1: 44.6 °C</p> <p>Bx1: 45.2 °C</p> <p>Recommendation: Found OK.</p>
63	3 rd floor Computer Lab-1 bus bar chamber

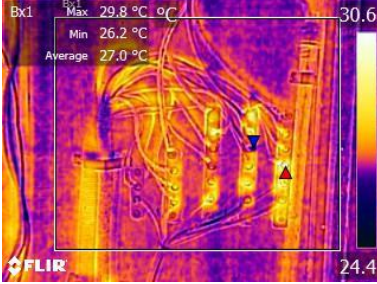
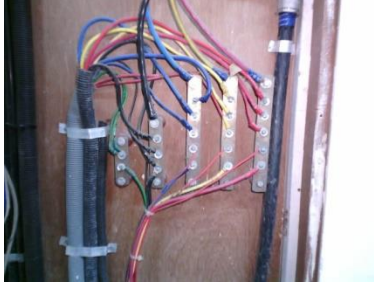
<p>Observation: Maximum temperature observed on bus bar cable terminals is Bx1: 29.8 °C</p> <p>Recommendation: Found OK.</p>

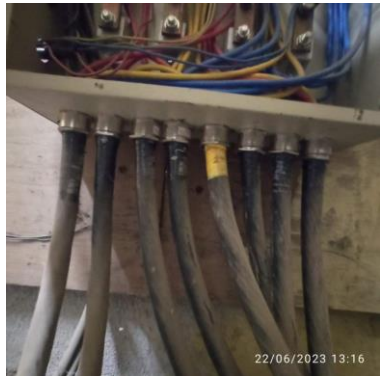
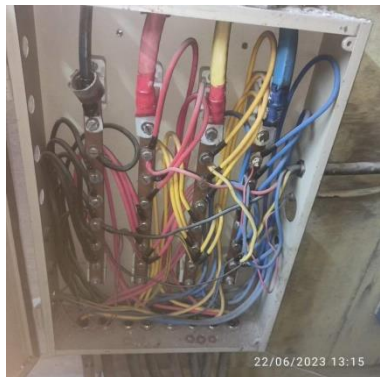
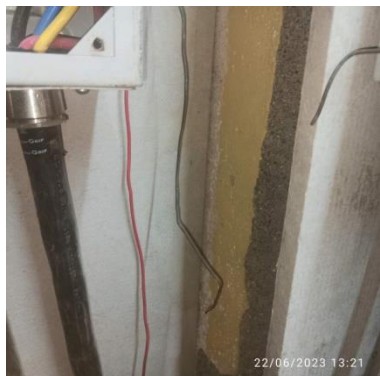
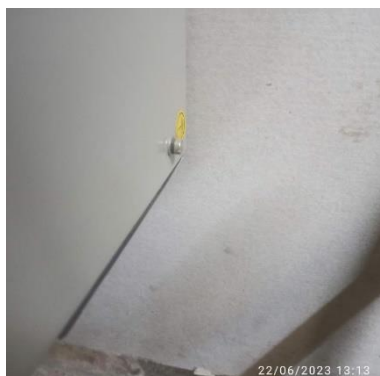
<p>7. Dust is observed in electric Panel.</p> <p>8. Protective earth conductor is found disconnected and not connected to SFU, Busbar chamber and MCCB enclosure body earth.</p>	<p>7. Proper preventive maintenance is need to be carried out in electrical DB at regular interval.</p> <p>8. It is recommended to Provide 25*3 size GI earth strip for protective body Earthing to SFU, Busbar chamber and MCCB enclosure body earth as Per IS3043.</p>
--	--	--	--	--

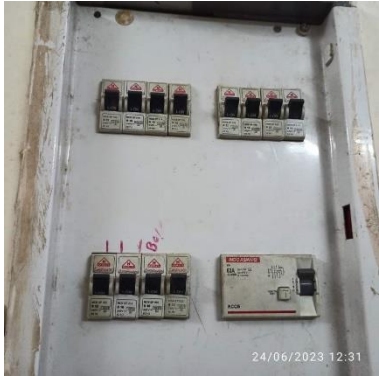
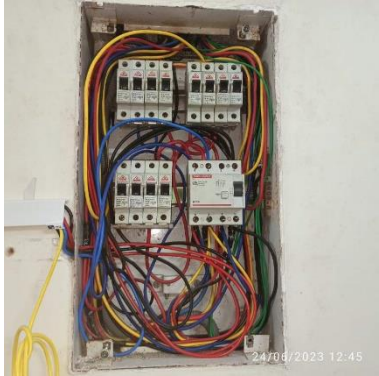
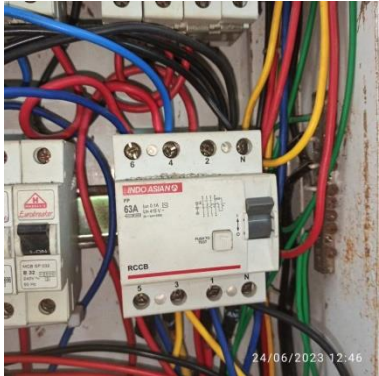
<p>9</p> <p>2nd Floor Room No- 212</p>

<ol style="list-style-type: none"> 1. Tagging is not observed on all MCB for identification. 2. Dust is observed in electric DB. 3. Lugs are not observed on wire terminal of MCB. 4. Looping is observed on SP MCB. 5. Multiple wires are connected at RCCB outgoing and incoming terminal. 	<ol style="list-style-type: none"> 1. It is recommended to affix tag on MCB for identification. 2. Proper preventive maintenance is need to be carried out in electrical DB at regular interval. 3. It is recommended to install rated size of pin type cu lugs on all circuit wiring and make all termination tight properly as per NEC 2023. 4. Looping are need to be removed and connect rated size of copper shorting link at SP MCB incomer 5. It is recommended to connect one wire at RCCB terminal to avoid overloading, loose connection and unwanted tripping on respective circuit.

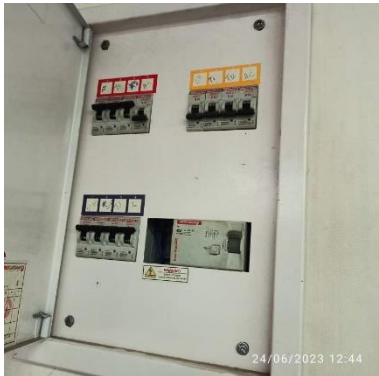
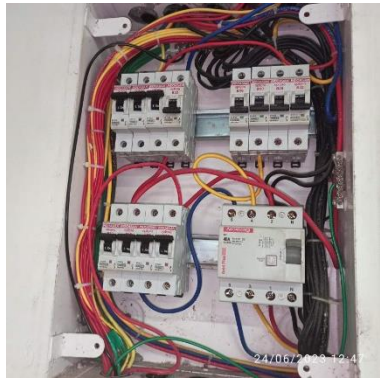
<p>10</p> <p>2nd Floor Room No- 202</p>

<ol style="list-style-type: none"> 1. Tagging is not observed on all MCB for identification. 2. Lugs are not observed on wire terminal of MCB. 	<ol style="list-style-type: none"> 1. It is recommended to affix tag on MCB for identification. 2. It is recommended to install rated size of pin type cu lugs on all circuit wiring and make all termination tight properly as per NEC 2023.

<p>3. Dust is observed in electric DB.</p>	<p>3. Proper preventive maintenance is need to be carried out in electrical DB at regular interval.</p>
11	2 nd Floor Room No-203

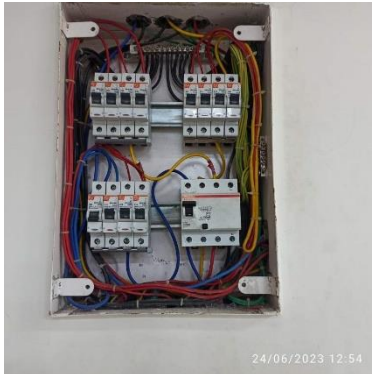
<p>1. Tagging is not observed on all MCB for identification.</p> <p>2. Lugs are not observed on wire terminal of MCB.</p> <p>3. Dust is observed in electric DB.</p>	<p>1. It is recommended to affix tag on MCB for identification.</p> <p>2. It is recommended to install rated size of pin type cu lugs on all circuit wiring and make all termination tight properly as per NEC 2023.</p> <p>3. Proper preventive maintenance is need to be carried out in electrical DB at regular interval.</p>
12	2 nd Floor Room No-213

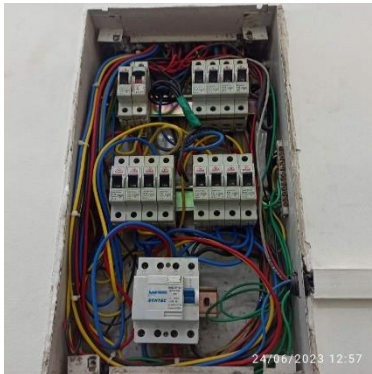
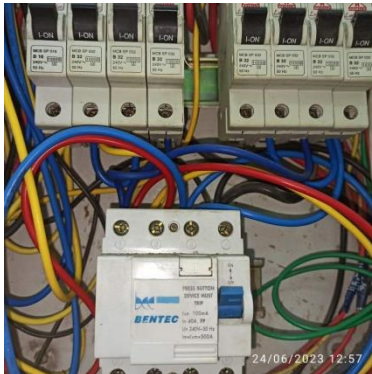
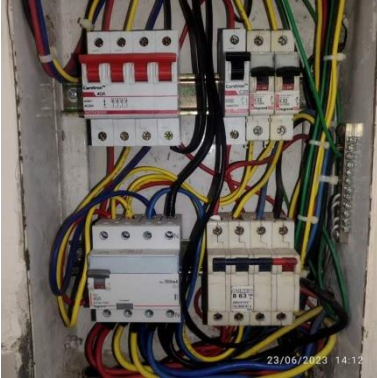
<p>1. Tagging is not observed on all MCB for identification.</p> <p>2. Dust is observed in electric DB.</p> <p>3. Lugs are not observed on wire terminal of MCB.</p> <p>4. Looping is observed on SP MCB.</p>	<p>1. It is recommended to affix tag on MCB for identification.</p> <p>2. Proper preventive maintenance is need to be carried out in electrical DB at regular interval.</p> <p>3. It is recommended to install rated size of pin type cu lugs on all circuit wiring and make all termination tight properly as per NEC 2023.</p> <p>4. Looping are need to be removed and connect rated size of copper shorting link at SP MCB incomer</p>

<p>3. Lugs are not observed on wire terminal of MCB.</p>	<p>3. It is recommended to install rated size of pin type cu lugs on all circuit wiring and make all termination tight properly as per NEC 2023.</p>
<p>14</p>	<p>3rd Floor Room No-301 Electrical DB Computer lab 6</p>

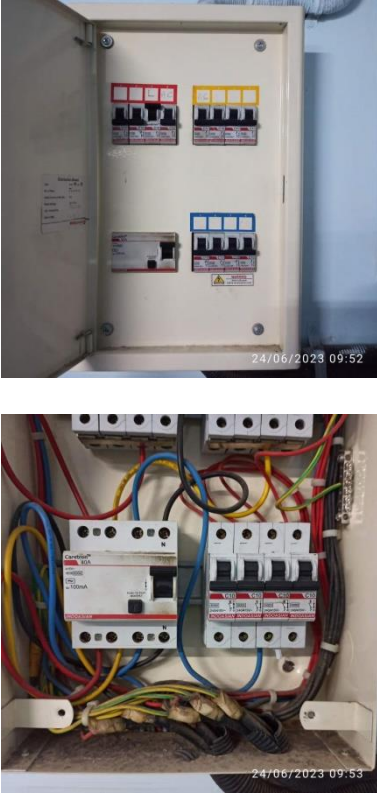
<p>1. Proper tagging is not observed on all MCB for identification.</p> <p>2. Dust is observed in electric DB.</p> <p>3. Lugs are not observed on wire terminal of MCB.</p>	<p>1. It is recommended to affix tag on MCB for identification.</p> <p>2. Proper preventive maintenance is need to be carried out in electrical DB at regular interval.</p> <p>3. It is recommended to install rated size of pin type cu lugs on all circuit wiring and make all termination tight properly as per NEC 2023.</p>
<p>15</p>	<p>3rd Floor Room No-302 Electrical DB Computer lab 5</p>

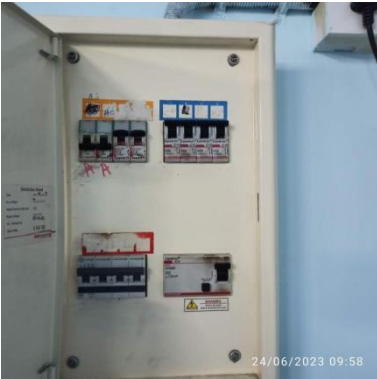
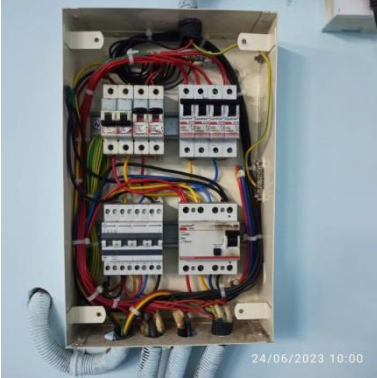
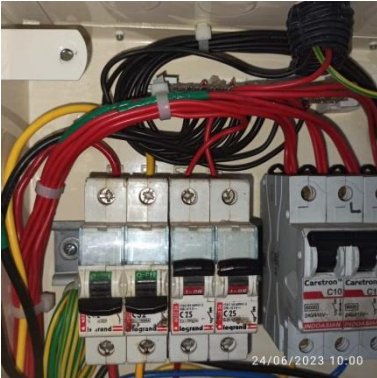
<p>1. Proper tagging is not observed on all MCB for identification.</p>	<p>1. It is recommended to affix tag on MCB for identification.</p>

<p>2. Dust is observed in electric DB.</p> <p>3. Lugs are not observed on wire terminal of MCB.</p>	<p>2. Proper preventive maintenance is need to be carried out in electrical DB at regular interval.</p> <p>3. It is recommended to install rated size of pin type cu lugs on all circuit wiring and make all termination tight properly as per NEC 2023.</p>
<p>16</p>	<p>3rd Floor Room No- 303 Electrical DB Computer lab 4</p>

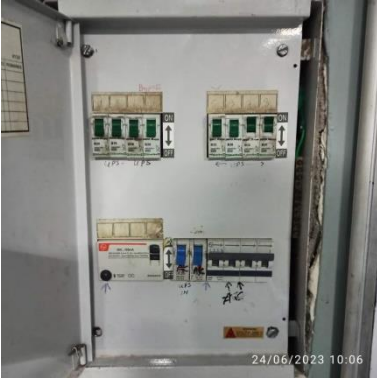
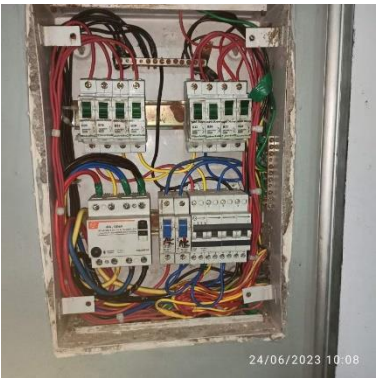
<p>1. Proper tagging is not observed on all MCB for identification.</p> <p>2. Dust is observed in electric DB.</p> <p>3. Lugs are not observed on wire terminal of MCB.</p>	<p>1. It is recommended to affix tag on MCB for identification.</p> <p>2. Proper preventive maintenance is need to be carried out in electrical DB at regular interval.</p> <p>3. It is recommended to install rated size of pin type cu lugs on all circuit wiring and make all termination tight properly as per NEC 2023.</p>

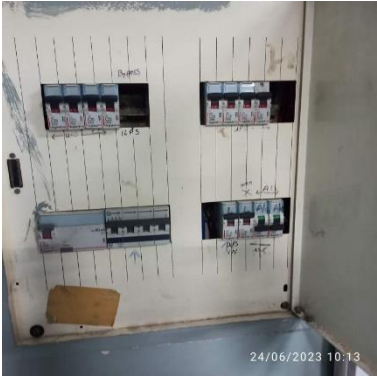
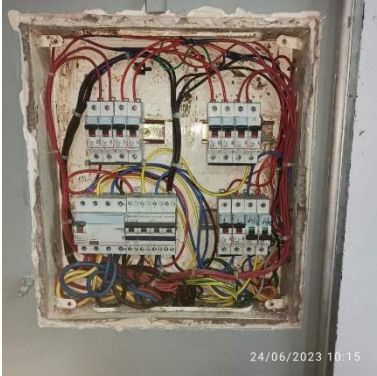
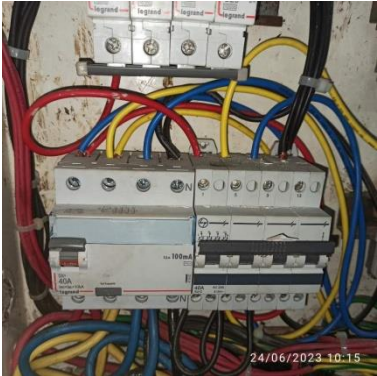
<p>17</p> <p>3rd Floor Room No- 304 Electrical DB Computer lab 3</p>

<ol style="list-style-type: none"> 1. Proper tagging is not observed on all MCB for identification. 2. Dust is observed in electric DB. 3. Lugs are not observed on wire terminal of MCB. 	<ol style="list-style-type: none"> 1. It is recommended to affix tag on MCB for identification. 2. Proper preventive maintenance is need to be carried out in electrical DB at regular interval. 3. It is recommended to install rated size of pin type cu lugs on all circuit wiring and make all termination tight properly as per NEC 2023.
<p>18</p> <p>3rd Floor Room No- 305 Electrical DB Computer lab 2</p>

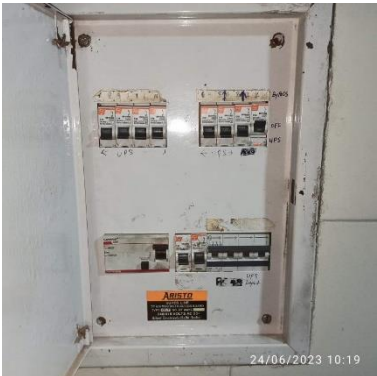
<ol style="list-style-type: none"> 1. Proper tagging is not observed on all MCB for identification. 2. Dust is observed in electric DB. 3. Lugs are not observed on wire terminal of MCB. 	<ol style="list-style-type: none"> 1. It is recommended to affix tag on MCB for identification. 2. Proper preventive maintenance is need to be carried out in electrical DB at regular interval. 3. It is recommended to install rated size of pin type cu lugs on all circuit wiring and make all termination tight properly

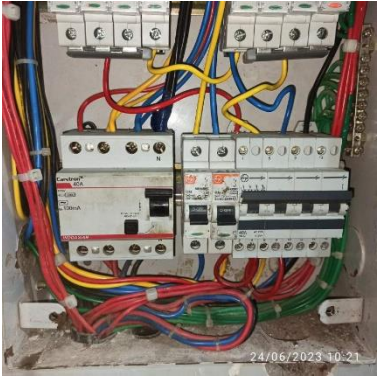
<p>4. Multiple neutral wires are connected at RCB neutral terminal.</p>	<p>as per NEC 2023.</p> <p>4. It is recommended to connect circuit neutral wire at neutral link in DB.</p>
<p>19</p>	<p>3rd Floor Room No- 306 Electrical DB Computer lab 1</p>

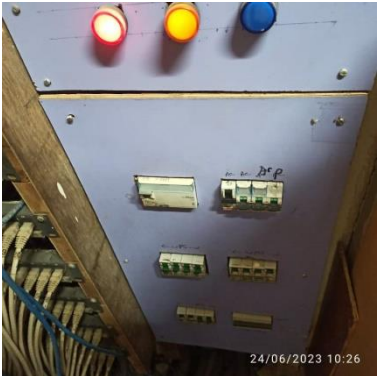
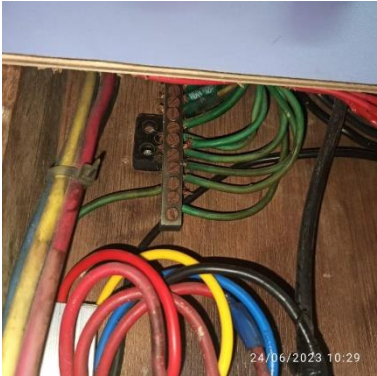
<p>1. Proper tagging is not observed on all MCB for identification.</p> <p>2. Lugs are not observed on wire terminal of MCB.</p> <p>3. Earth link screw are found rusted.</p>	<p>1. It is recommended to affix tag on MCB for identification.</p> <p>2. It is recommended to install rated size of pin type cu lugs on all circuit wiring and make all termination tight properly as per NEC 2023.</p> <p>3. It is recommended to clean earth link terminal with properly and make connection at earth link terminal.</p>
<p>20</p>	<p>3rd Floor Room No- 313 Electrical DB</p>

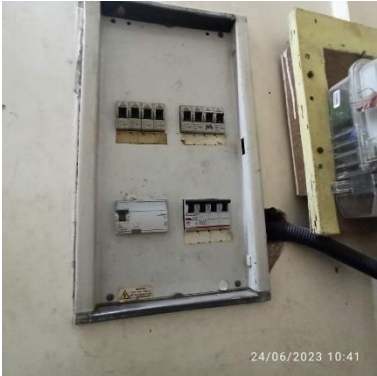
<p>1. Proper tagging is not observed on all MCB for identification.</p> <p>2. Lugs are not observed on wire terminal of MCB.</p>	<p>1. It is recommended to affix tag on MCB for identification.</p> <p>2. It is recommended to install rated size of pin type cu lugs on all circuit wiring and make all termination tight properly as per NEC 2023.</p>

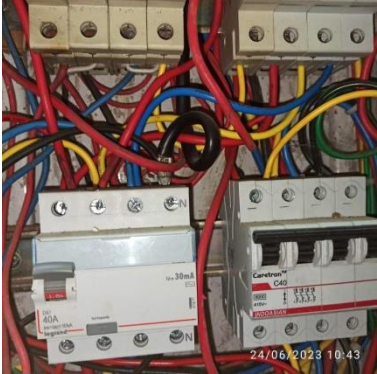
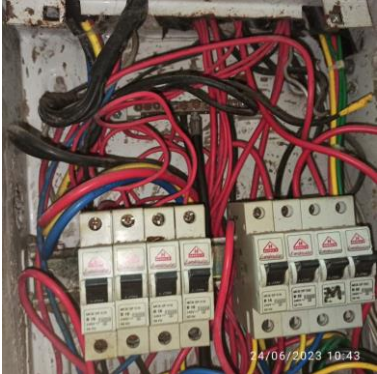
<p>3. Multiple wires are connected at RCCB outgoing and incoming terminal.</p> <p>4. Neutral link screw are found rusted.</p>	<p>3. It is recommended to connect one wire at RCB terminal to avoid overloading, loose connection and unwanted tripping on respective circuit.</p> <p>4. It is recommended to clean neutral link terminal with properly and make connection at neutral link terminal.</p>
21	3rd Floor Kitchen Electrical DB

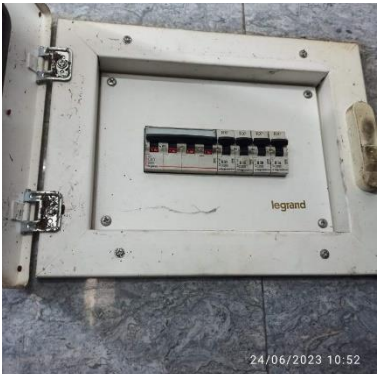
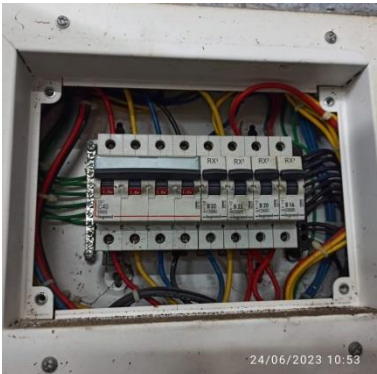
<p>1. Proper tagging is not observed on all MCB for identification.</p> <p>2. Dust is observed in electric DB.</p> <p>3. Lugs are not observed on wire terminal of MCB.</p>	<p>1. It is recommended to affix tag on MCB for identification.</p> <p>2. Proper preventive maintenance is need to be carried out in electrical DB at regular interval.</p> <p>3. It is recommended to install rated size of pin type cu lugs on all circuit wiring and make all termination tight properly as per NEC 2023.</p>

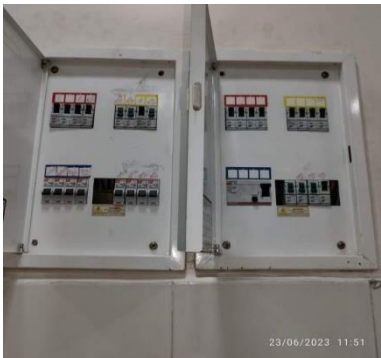
<p>1. Proper tagging is not observed on all MCB for identification.</p>	<p>1. It is recommended to affix tag on MCB for identification.</p>

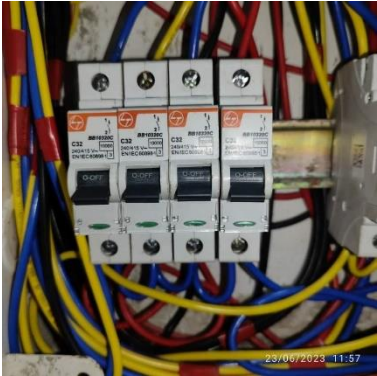
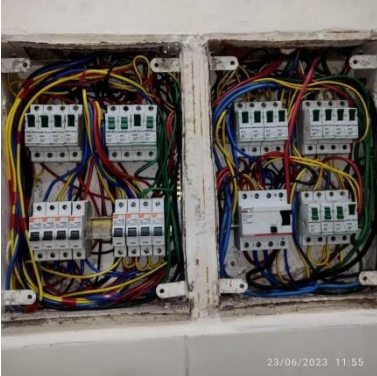
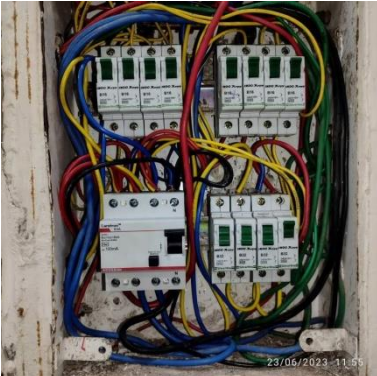
<p>2. Looping is observed on SP MCB.</p> <p>3. Dust is observed in electric DB.</p> <p>4. Multiple wires are connected at RCCB outgoing terminal.</p>	<p>2. Looping are need to be removed and connect rated size of copper shorting link at SP MCB in-comer.</p> <p>3. Proper preventive maintenance is need to be carried out in electrical DB at regular interval.</p> <p>4. It is recommended to connect one wire at RCCB terminal to avoid overloading, loose connection and unwanted tripping on respective circuit.</p>
<p>26</p>	<p>5th Floor Room No- 513 Electrical DB</p>
